C&TS DISPATCH

CUMBRES CAR INSPECTOR'S HOUSE STABILIZATION PRESERVATION RESTORATION RECONSTRUCTION, PART 2: 2013-2021

Vol. 34, No. 4 Winter 2021

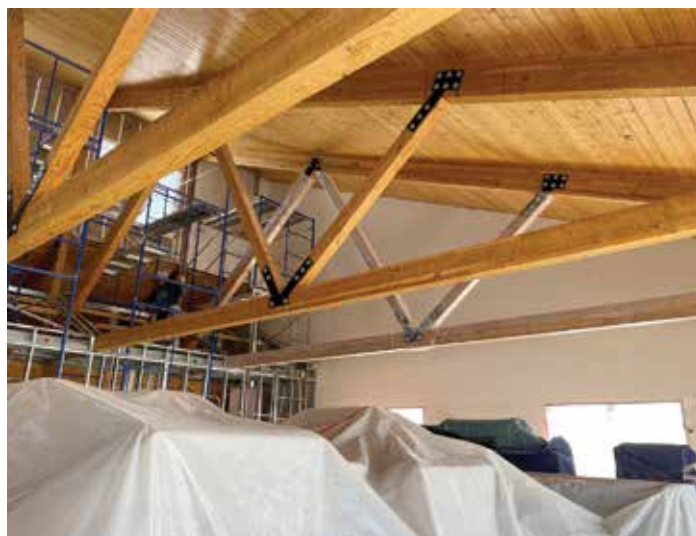
At 8:45 the morning of September 23rd, the Railroad received a call from the staff of Toltec Catering that the Osier Dining Hall was on fire. The fire had started downstairs in the bakery and spread into the pantry. Fortunately, a ruptured pipe doused the fire before it could spread further, although the building suffered severe damage. ServePro of Durango started work on recovery of the building the following day. With the dry weather through November and December, we were able to work until December 22. We will not be able to do further work on the building until after the spring thaw.

The recovery efforts have been extensive. All the dry wall was removed, along with all the building insulation. All the walls were scrubbed and the roof beams and wooden roof structure were hand washed. The bathroom plumbing was replaced. The walls and ceiling were sealed. As of December 22, the insulation throughout the building and all the drywall in the dining hall had been replaced. This spring the drywall on the lower floor will be replaced, along with the damaged drain piping and the drop ceiling.

The main power wiring will need to be replaced due to heat damage.

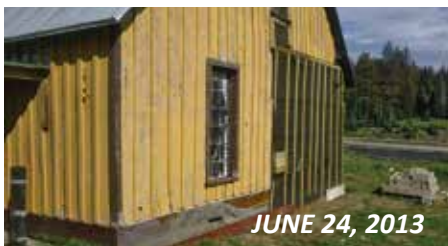
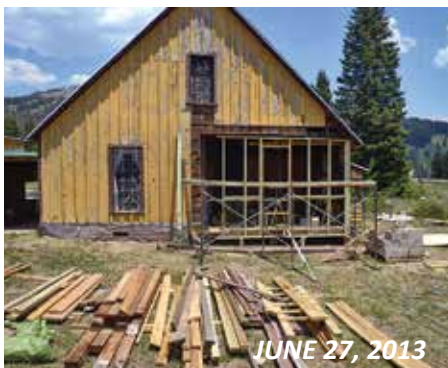
When they removed the wall that had replaced the non-original garage door, they found that a switch tie had been used over the garage door as a header with two regular ties for support. Bob and his team removed the ties and framed a new wall and window with 2x4s that had been stacked inside the building. In his Team Leader report, Bob noted that “a lot more work needs to be done,” a rather prescient statement when we look back from 2022. As always, that work was

The location of the old garage door was rebuilt with stronger materials.

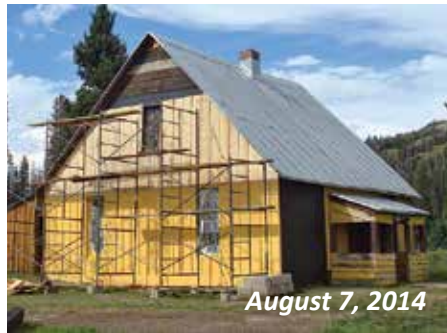
New framing and sheathing replaced the old on the Chama side of the building.

During the 2014 season most of the Chama-end wall sheathing and all the siding was torn off, down to the studs. Bad studs and plates were replaced, and the wall was resheathed and resided with a new exterior, lacking the attendant battens. With the bulges gone and the wall re-sheathed, the house was returned to some degree of stability, although the second floor was still canted slightly toward Antonito.

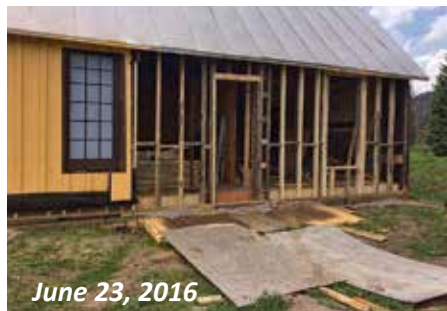
Much of the building’s front exterior was torn down to the studs for repair or replacement, then re-sheathed.

In 2016, Friends returned to the Car Inspector’s House, focusing on the front of the building, the most visible side, facing the tracks. First, the old “front porch” was torn down. With the porch gone, restoration work could begin on the portions of the front wall that had not been upgraded when the Chama-side/garage door wall was rebuilt in 2013. Like the Chama side, studs and sills were repaired and new siding and sheathing were installed.

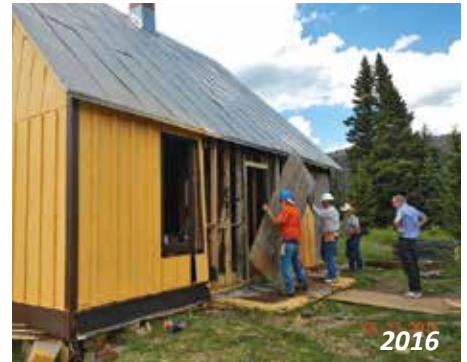
The crew begins installing the inside sheathing around the door before adding the board and batten exterior.

The Antonito-side wall was partially refurbished as well during three work sessions in 2016. Like the front wall, wood was removed down to the studs for repairs. However, the end of the sessions came too soon and there wasn’t time to replace or repair the sheathing or install new siding. The building was forced to over-winter with tarps covering the first-floor section of the wall.

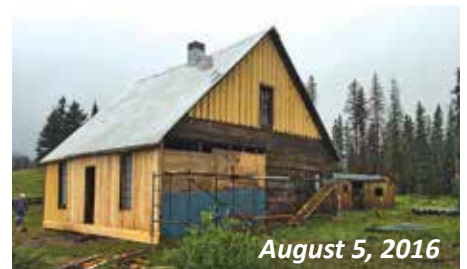
With the front sheathed in, work moved to the Antonito side of the house. Time ran out and the east wall wasn’t completed. Take note of the far end of the building and you will see a degree of “sag” in both the roof line and the bottom of the wall.

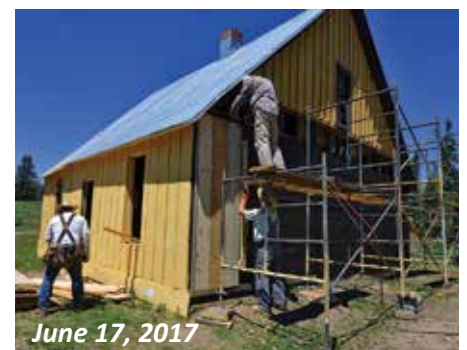
After waiting out the winter, the Antonito (north) side of the structure was also re-sheathed with board and batten siding.

During Sessions C and D of 2017, the Antonito-side wall that had been tarped over for the winter was completed, first by tearing out the rest of the old wall and replacing it with new

sheathing and finished board and battens. With the side wall completed, work moved to the back side adjacent to the annex portion of the building.

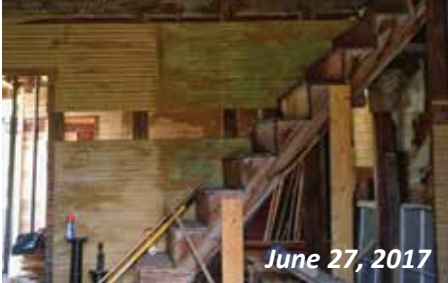
The original chimney was in particularly bad condition. Sometime in the past the chimney had been filled with scrap brick and capped, making it useless.

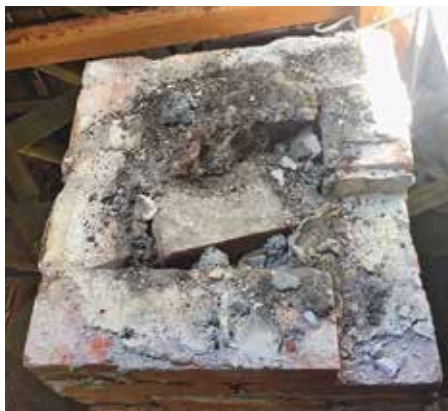
For unknown reasons bricks and debris had been used to plug the single-flue chimney.

The chimney had also cracked and shifted over the years, either by the attempts at leveling and straightening the house over the years or by high winds on the pass that rocked, twisted and shifted the already-weakened structure. Either way, the chimney had to go.

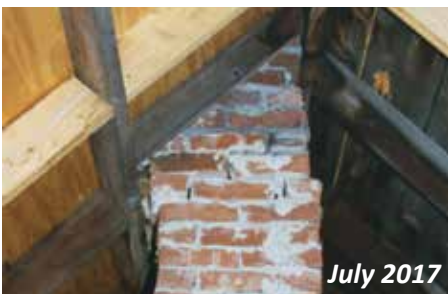
An accident waiting to happen. Unless it's repaired, one might need to wear a hard hat inside the building.

Working both inside and outside, deconstruction of the broken chimney began. Ladders were placed on the roof for easy and safe access and a platform was built to begin the disassembly of the chimney at the roof peak.

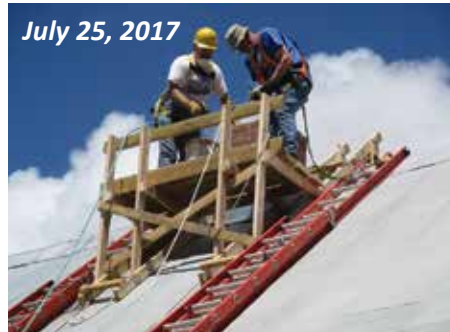
The roof of the Car Inspector's House has a 12:12 pitch, that is 45°. A platform was built to provide a safe work space.

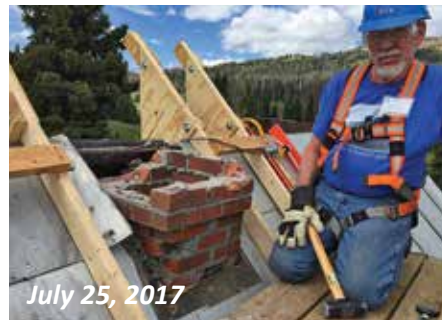
Like masons in reverse, John Pierce, Vance Behr and George Trever broke each brick free of the chimney's bonding mortar.

Working their way down the chimney, John Pierce, George Trever and Vance Behr broke bricks from the ancient mortar. It wasn't difficult; the bond of the old mortar was so weakened that a simple tap or kick, sometimes just a gloved hand was enough to break each brick loose. With the chimney gone, a temporary metal cap was placed to seal the hole in the roof.

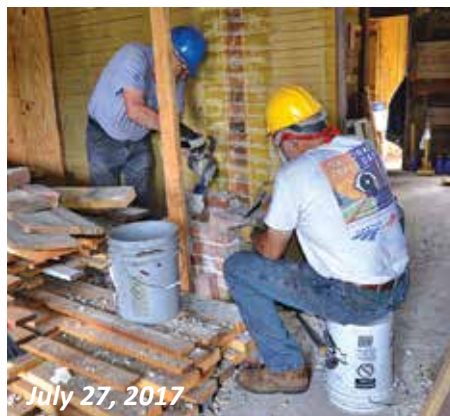
Brick by brick, the chimney was disassembled down to its base and footing.

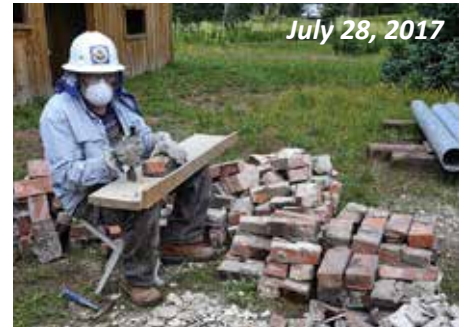
Removing the bricks was not the final step of the disassembly. George Trever cleaned and sorted the old bricks for future use.

The bricks, however, were not discarded. Should the chimney to be rebuilt in the future, some of the bricks could be reused to support the "originality" of the structure. George Trever was able to salvage and set aside over 600 full bricks by cleaning off the old mortar and setting them aside for the future. No small task!

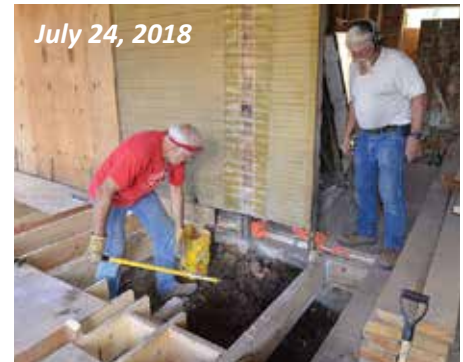
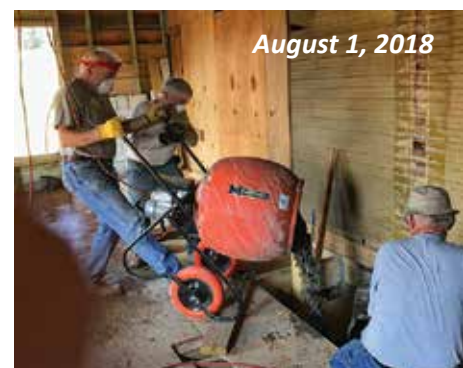
The original chimney foundation is gone and a new, reinforced foundation was poured in its place.

During the 2018 season, with the chimney out of the way, the original chimney foundation was demolished and a new 24-inch deep footing was poured for later reconstruction of a code-compliant, single-flue chimney. This required digging out the original foundation and pouring a new one in

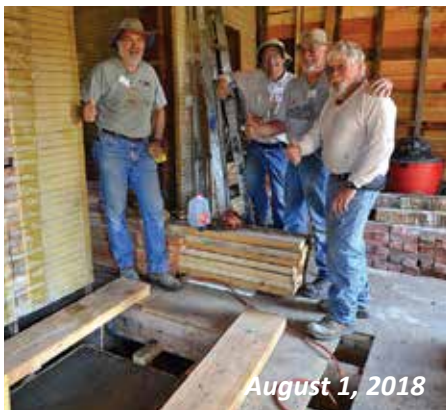
The new foundation in place, Vance Behr, Wayne Shirley, John Pierce and Bob Conry celebrate a footing that would later be replaced with a larger one.

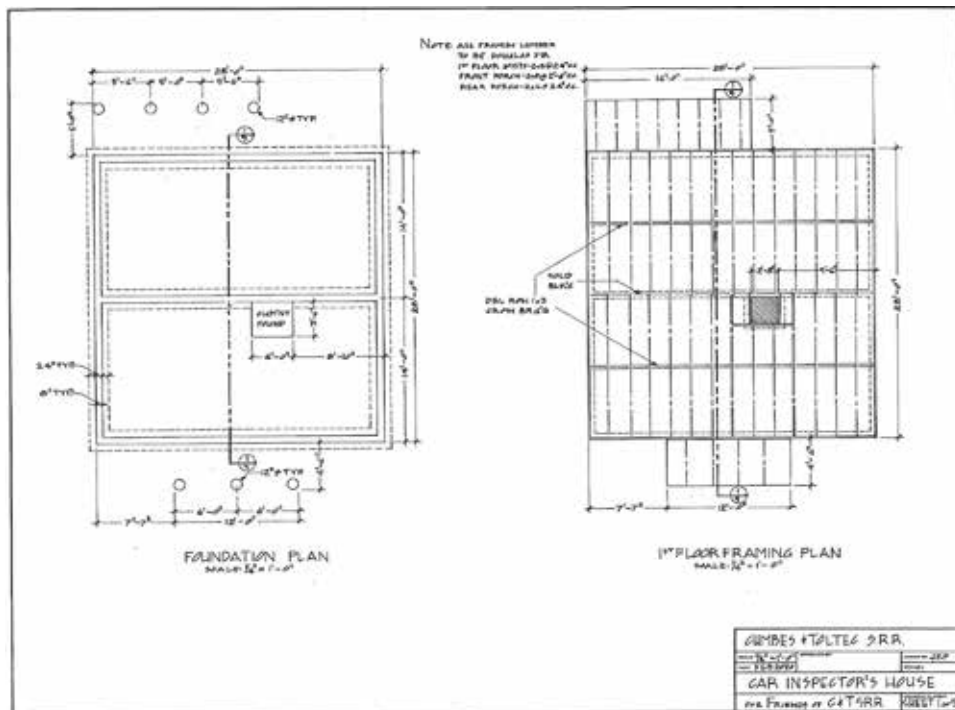
John Pierce's exquisite architectural renderings, (two of his five drawings shown here) helped make reconstruction of the Car Inspector's House possible.

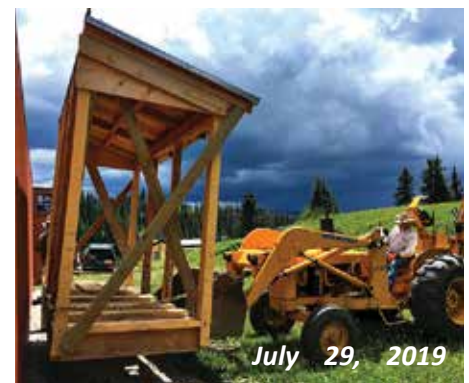
During the next two 2019 Sessions, E and F, the front porch was removed

as a unit and set beside the storage container for later reinstallation.

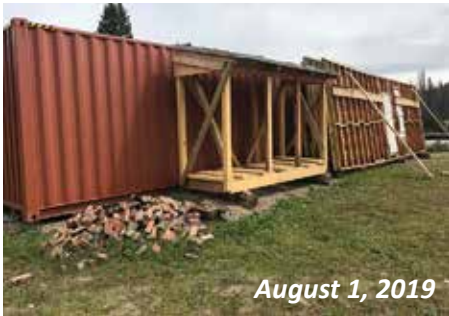
The porch and wall sections were salvaged for use in the new structure and the old foundation. The site was now ready for new construction to begin.

walls were moved without disassembly and stacked at the storage container along with the porch. The wooden foundation that had served as well as it could since 1995 was removed.

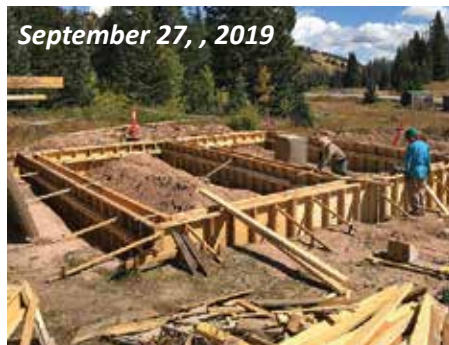
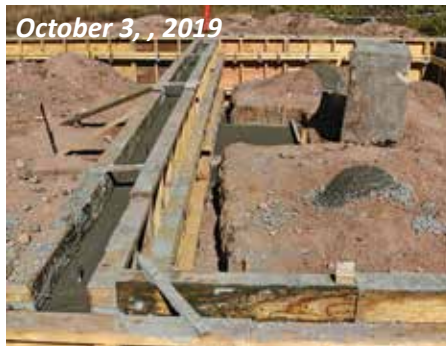
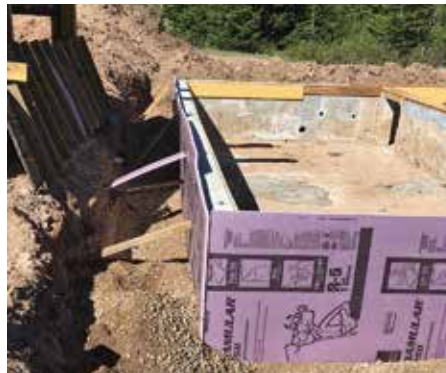
Rigid foam insulation protects the foundation from the frozen ground.

Trenches for the new foundation were dug, and forms for the footings, stem walls and the rest of the foundation were set and poured. The pouring included a new larger footing for the chimney, replacing the one built in 2019.

When cured, the forms were stripped, rigid foam insulation was

installed and the trenches were back-filled to prevent freeze-thaw damage. By now it was late October and winter was just around the corner. The work was completed with no time to spare.

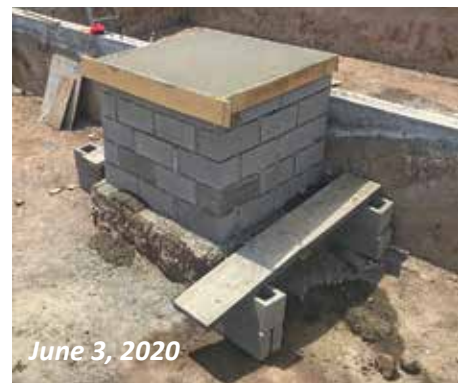
The pedestal will support the two-story, two-flue chimney.

Vance Behr and John Pierce built the chimney's masonry pedestal foundation atop the newly-poured footing and just below the level of the first floor.

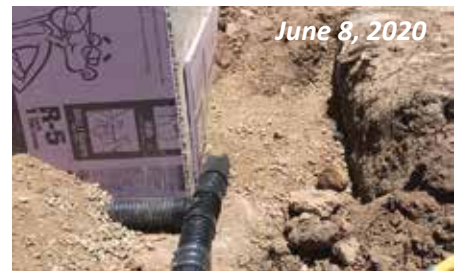
Keeping the moisture away from the foundation was paramount to the long-term stability of the entire structure.

For drainage around the structure, Bob Conry and Ron Horejsi installed a French drain consisting of a per-

forated pipe embedded in gravel to collect runoff and carry it through a drain line to a dry cistern away from the building pad. This would help protect the foundation from absorbing run-off that damaged the original structure.

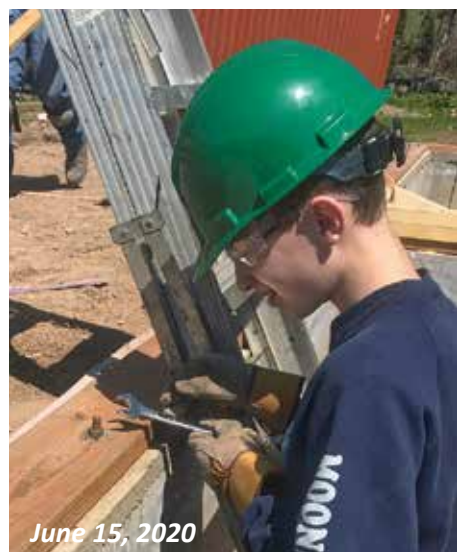
Clayton Buttram, Vance Behr's grandson, tightens the nuts on the sill plate before framing begins.

The stem walls were topped out for compatible mudsill framing, with the mudsills installed thereafter. Bolts placed in the foundation during the pour provided the attachment points for the bottom sill. This was just the

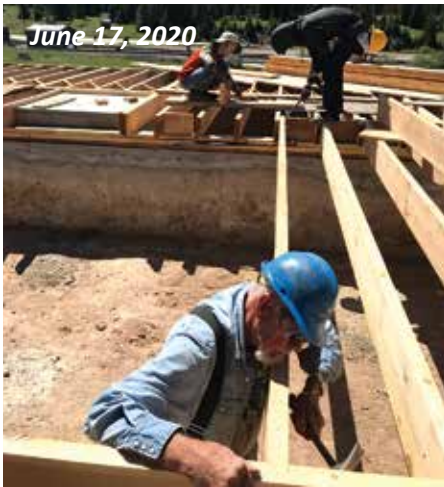
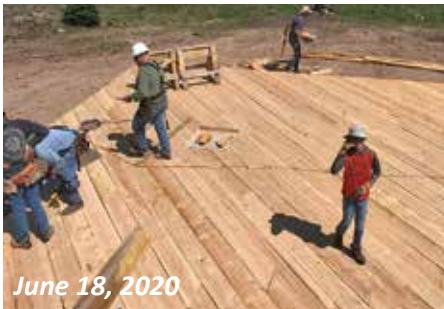
The first floor is in place, ready for the return of the saved walls. Note the location of the chimney pad.

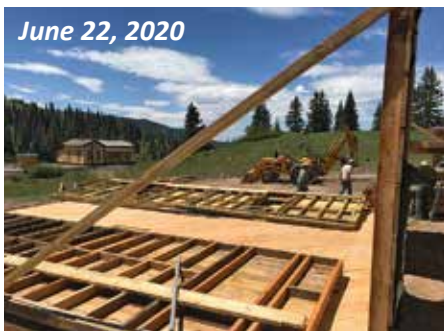
were raised into position and braced, and OSB sheer panels were installed on the corners; not original, but a code requirement for strength.

With the foundation and first floor complete, each section of the wall was moved from the storage shed to their positions on the decking where they

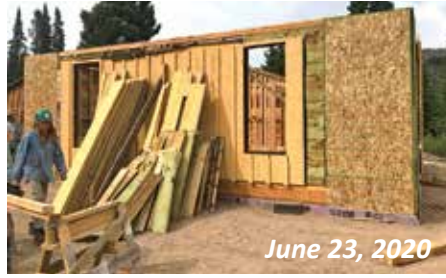
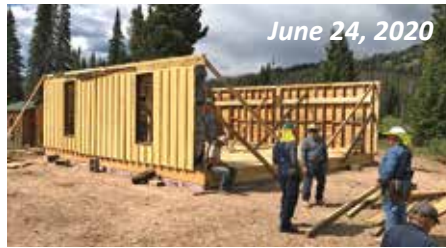
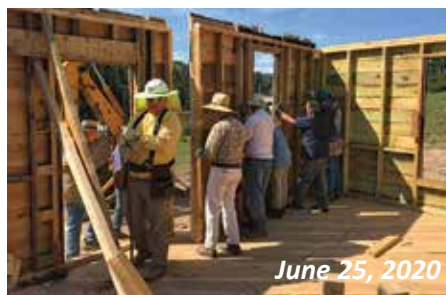
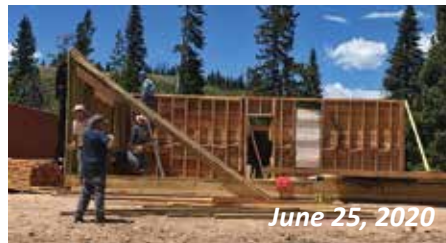
Like an Amish barnraising, the walls were lifted into place and their corners reinforced with OSB panels.

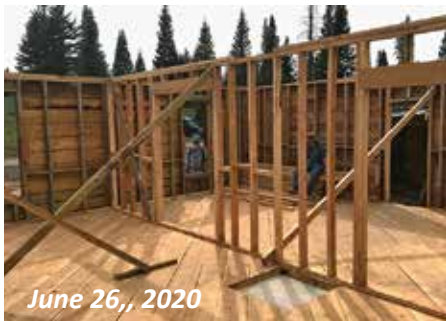
The interior load-bearing walls serve two purposes; dividing the first floor layout and providing support for the second floor joists.

July saw the first floor exterior walls and framing completed so work began on the center load-bearing walls, followed by the second-floor joists, bridging and decking.

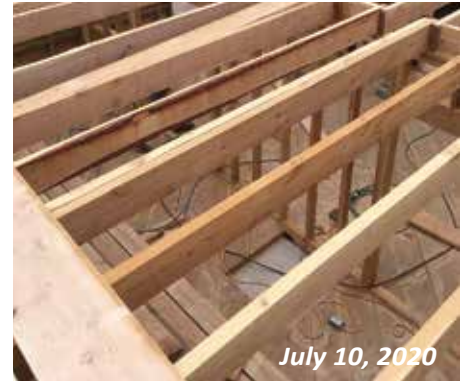
The concrete foundation, the first floor joists and decking, and the interior and exterior load-bearing walls will support not only the second floor but also the roof.

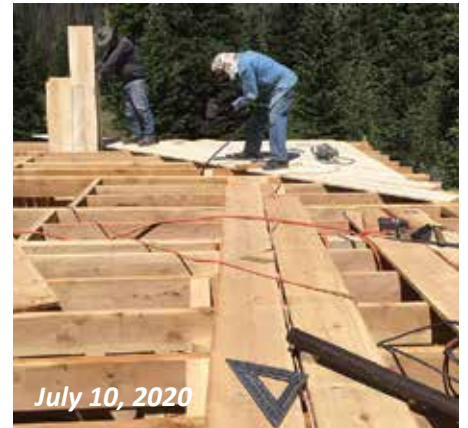
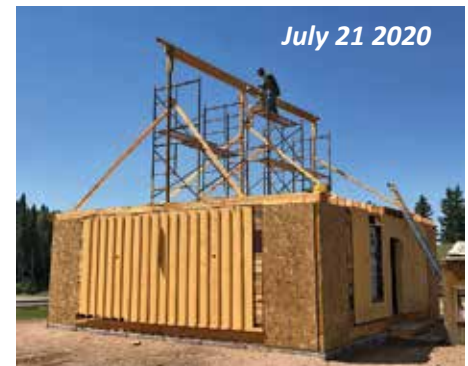
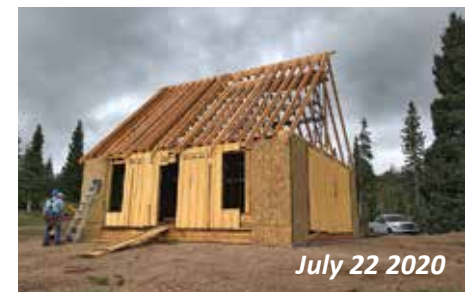
The roof was probably the most complex and most difficult portion of the building process.

constructed with prefabricated roof trusses, custom-made for the width and pitch of the roof. But this is no modern house. Therefore the roof was built in a traditional manner, probably similar to how the 1911 structure was

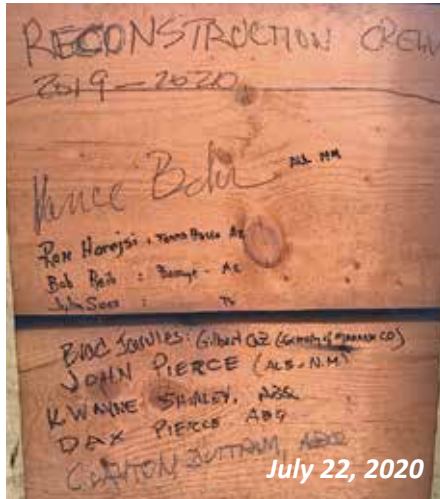
With the roof ridge board and rafters in place, the crew and helpers signed pieces of the interior sheathing to intrigue future historians.

built, by first setting a ridge beam and then attaching the correctly-spaced roof rafters between the ridge beam and the top of the first floor framing

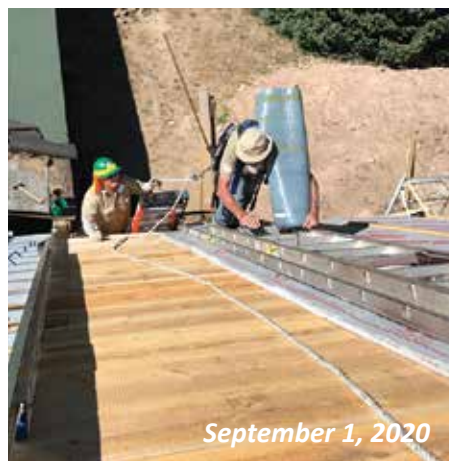
Bob Rieb, left, feeds materials to John Pierce, on the ladder and Vance Behr, on the roof with a camera and tools, as they begin the application of the “temporary” roof.

With the roof sheathing complete, in **early September**, Vance Behr and John Pierce applied what was to be a temporary roof with materials rated for a 180-day lifespan. As it was, the “temporary” roof would last until the final roofing material was spec'd, approved and professionally installed a full year later.

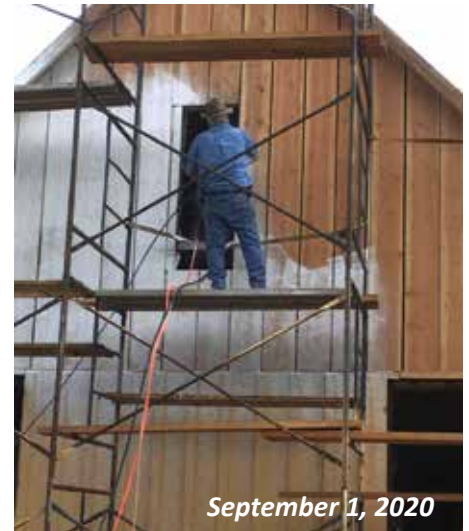
Brad Lounsbury applies a primer coat to one of the gabled ends of the building. Next up, the color coat of official Rio Grande gold.

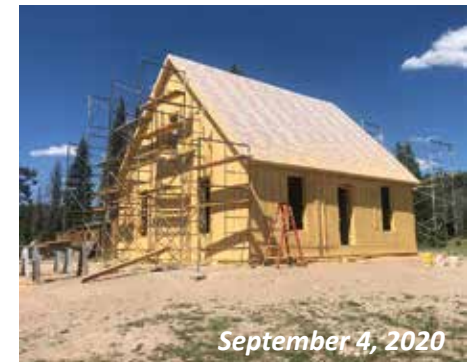
Primed, painted and with the “temporary” roof in place, the building is almost ready for the winter.

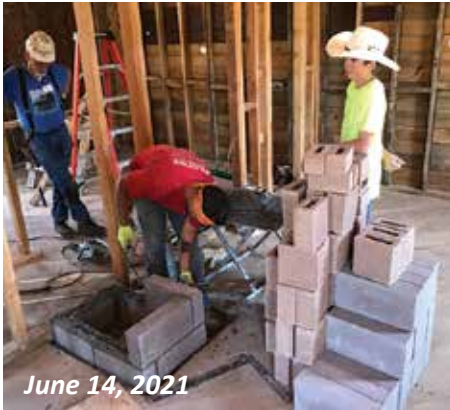
June 14, 2021

Wildfire Masonry arrived in June to begin construction of the new chimney, beginning on the first floor chimney pedestal.

The chimney construction began in **June of 2021**, Sessions C and D. Like the chimney pedestal in the foundation, standard blocks were used

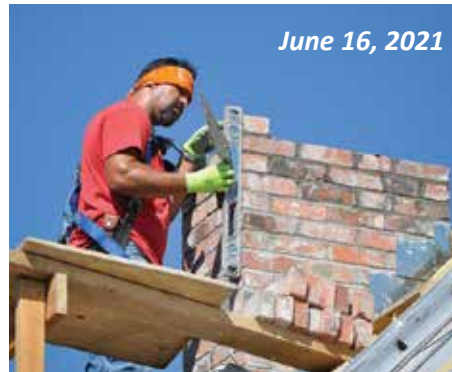
June 16, 2021

The crew worked their way up through the first floor, the second floor and up to just below the roof line with modern brick material. From the roof line on up, Wildfire used the same ladder and platform system used for dismantling the original chimney back in 2017. The crew completed the chimney with the salvaged brick and capped it with concrete.

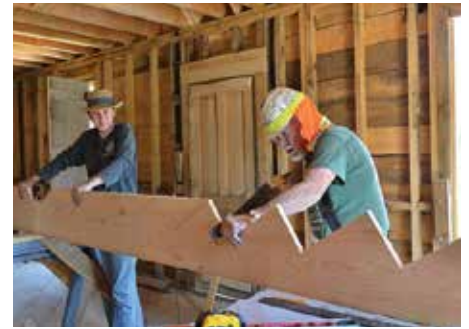
John Pierce, with assistance from Remington Templeton, began work on the new stairway.

Back inside, the staircase was framed in with the correct tread and riser sizing. The result was a stairway that closely resembled the original but fully code-compliant.

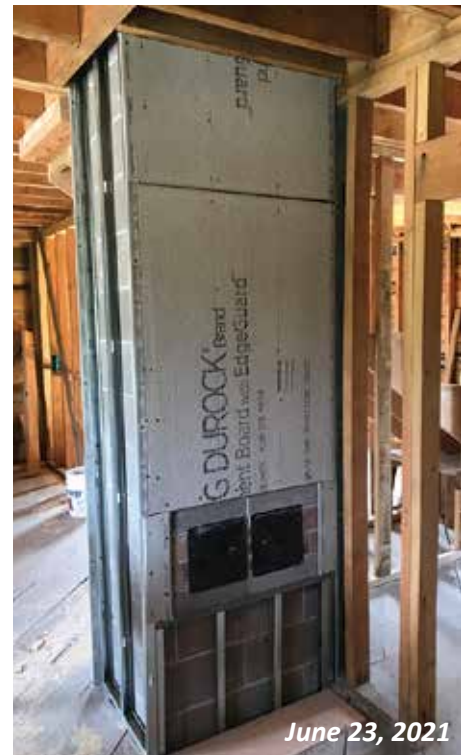
June 23, 2021

Inside, “backer board” was applied to the chimney for a plaster facade resembling the original facade.

The blocks that made up the chimney were sheathed with a cement “backer board.” Eventually a plaster coat will be applied to replicate the covering of original interior.

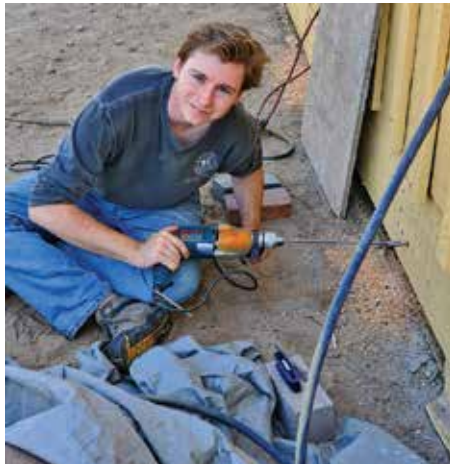
Remington Templeton part way through drilling 244 holes.

ern IBC code requires ventilation into the void of the crawl space, something that had not been included in construction of the new structure. Adding the multiple vents required multiple holes for each vent.

At the Car Inspector's House, Remington drilled through a combined five inches of full dimensional lumber, one inch of skirt board and a doubled joist, twenty-eight times for each of the eight vents. The trick was the blind drilling into the doubled joist where frequently an unseen nail would be encountered, ruining a drill bit. This totaled 224 holes and took quite a bit of energy, persistence and more than just a few drill bits. When he was done, metal-screened, louvered vents were then placed at the skirt board level on each of the four vents on each end of the house. The vents are clearly visible in the photo of the completed structure to the right.

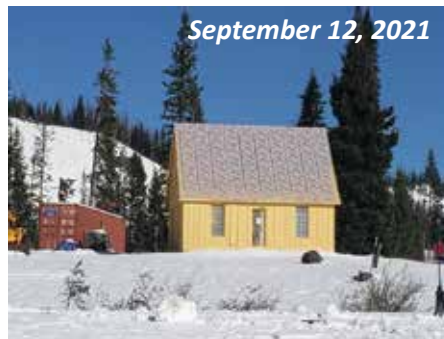
Almost completed for the season, the Car Inspector's House awaits its new, historically-accurate roof.

Finally, in very late October, Amcat Construction out of Durango finished the installation of the final permanent roof.

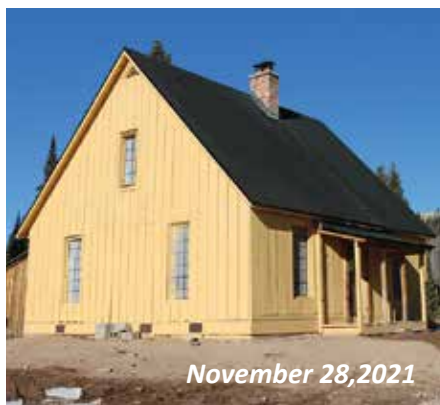
Temporary windows and doors in place and with complete final roof installation, the Car Inspector's House is ready for the winter.

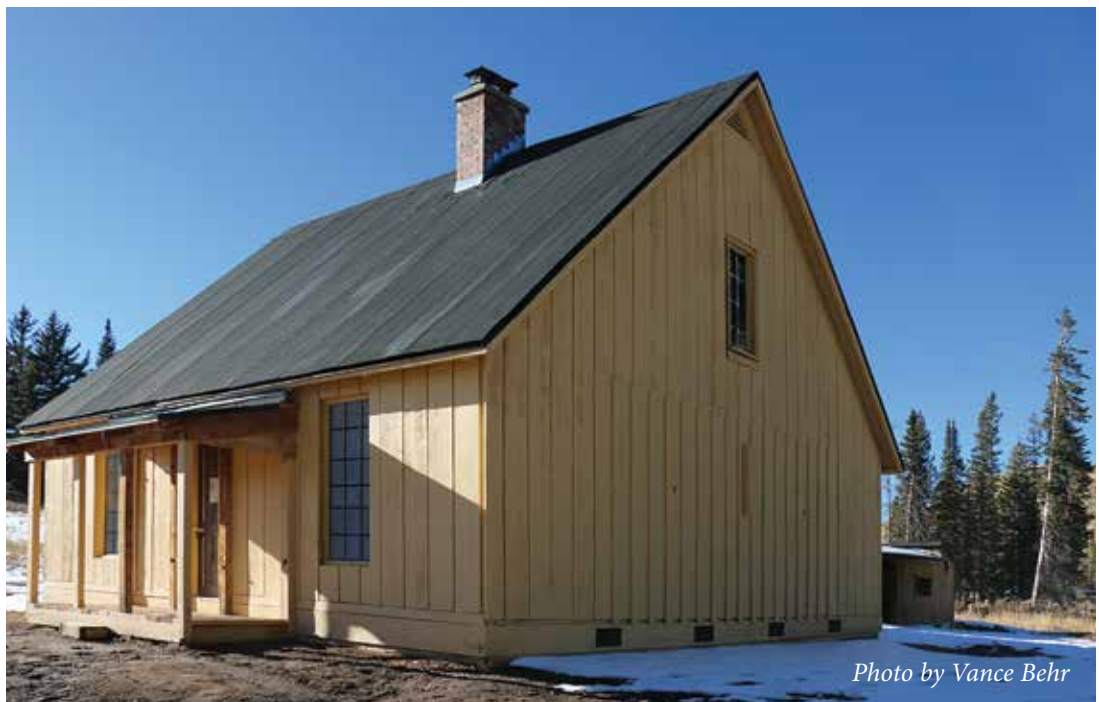
The Cumbres Car Inspector's House, restored by the Friends of the C&TS, November, 28, 2021.

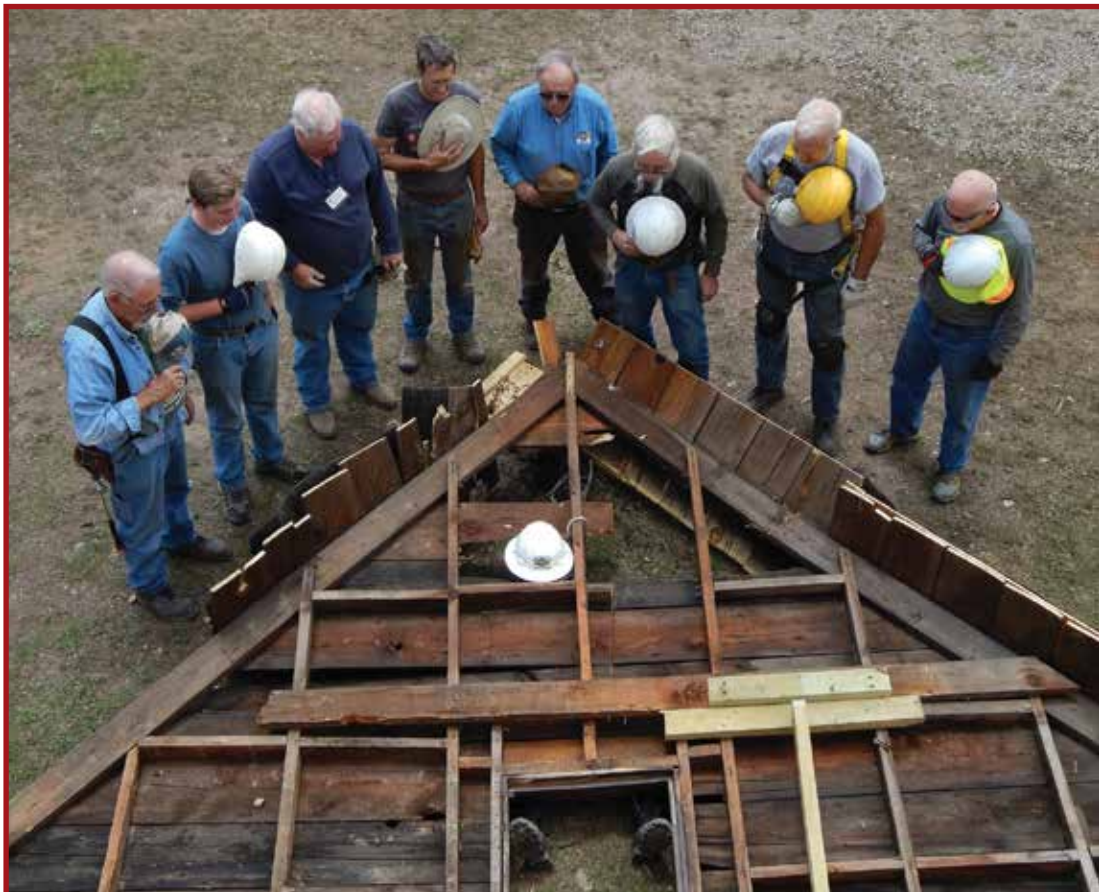
It was a sad day during the Session C of 2019 Car Inspector's House demolition project when an unidentified Friends volunteer didn't move quite quickly enough to get out of the way from the falling debris as the west roof wall peak was pulled down from the building. He will be missed. See page 6.
