# C&TS DISPATCH

**History and Restoration of the  
Cumbres Car Inspector's House, Part 1: 1917-2013**

Vol. 34, No. 3 🦋 Fall 2021

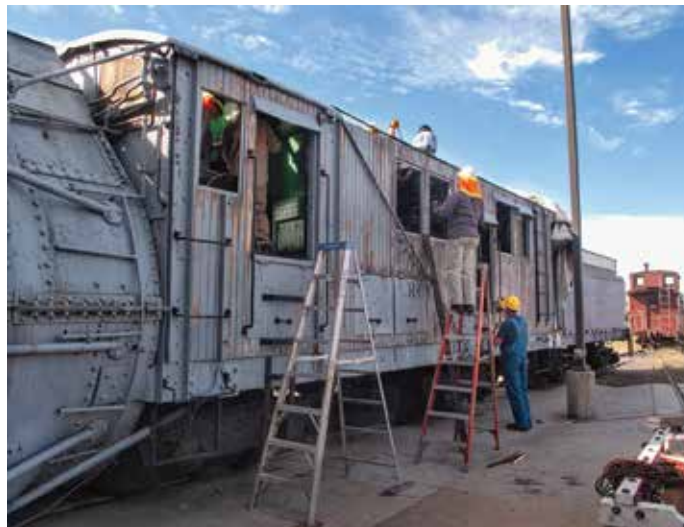
Exterior Rotary repairs, summer, 2019. Photo by Chris James

The Railroad moved Rotary OY from Chama to the Antonito CRF in June and we began working on it in July, after the Railroad paid an asbestos abatement company to complete remediation work. We found the old metal roof in very poor condition with numerous holes, resulting in extensive wood damage to the sub-roof and

the supporting structure. We removed both the metal and wood sub-roof, then repaired or replaced the carlines as needed and installed a new wooden sub-roof. We also manufactured and installed replacement doors and windows, repaired the end sill on the tender, replaced some of the siding, installed a new roof over the tender's coal area and prepped the Rotary for paint. We finished the work and turned over Rotary OY to the Railroad at the end of September.

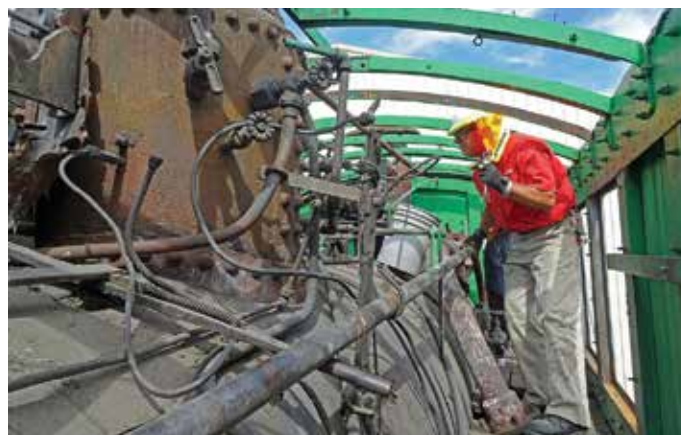
Inside the Rotary, summer 2019. Photo by Don Atkinson

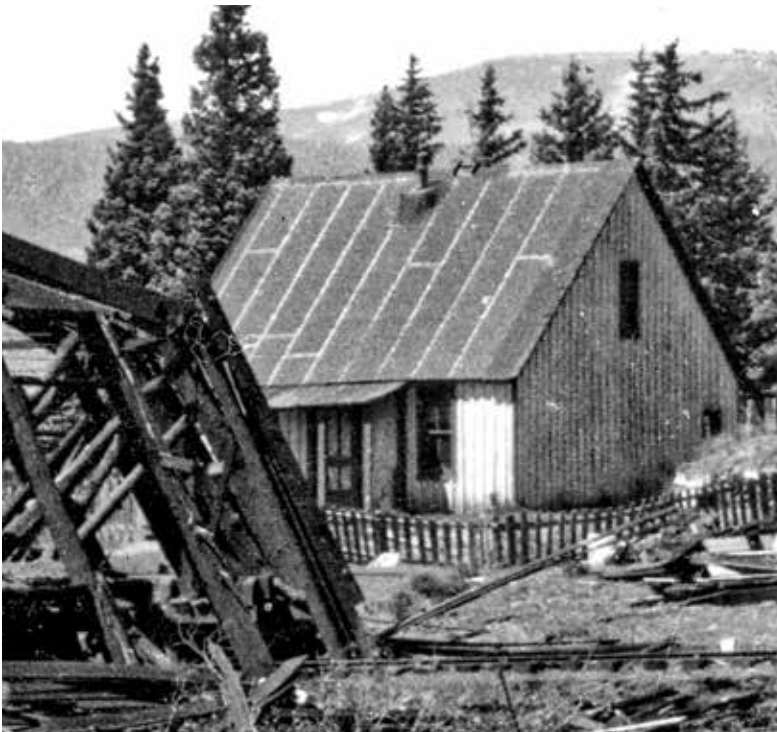
Photo by Charles R. Lively. FCTS RD013-102

*This is a portion of a photo taken to show the 1922 dismantling of the snowshed that covered the turntable. The Car Inspector's House looks fairly civilized, especially with the addition of a picket fence.*

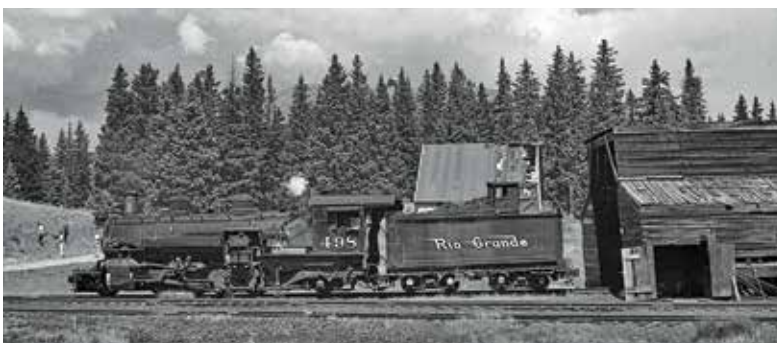
Photo by Ernie Robart. FCTS ERNG19670817-0333

*Forty-three years later, in 1965, the structure was showing its age. Portions of the roof have deteriorated down to bare boards.*

Nearly fifty years passed before the next known Car Inspector's House photo appears, taken by Ernie Robart in 1965. Only the roof of the building is visible behind K-37 No. 498 but it is obvious that the deterioration of the structure is already well-advanced with pieces of the roof missing down to the roof decking.

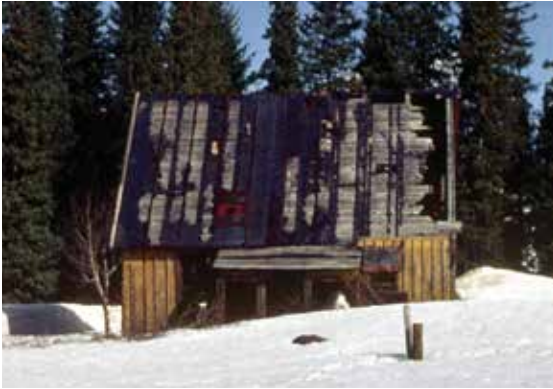
FCTS Dorman Collection, RDS080-111

*The Car Inspector's House as it appeared in the winter of 1979. The track-side-facing roof took the brunt of the sun and wind damage.*

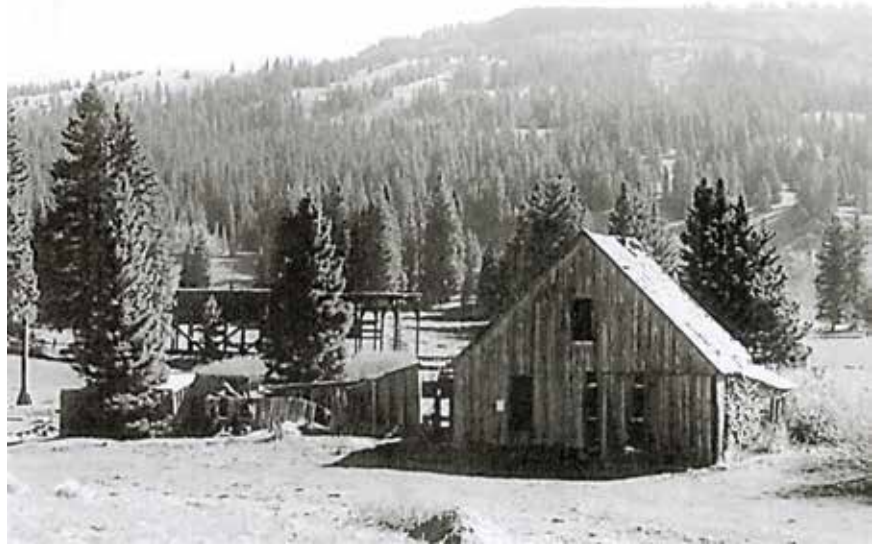
*In 1989, the Friends began surveying the building, planning for stabilization projects to begin the following year. To the left, shown here from the Chama side, is what remains of the annex and covered walkway. Photo by David Dye*

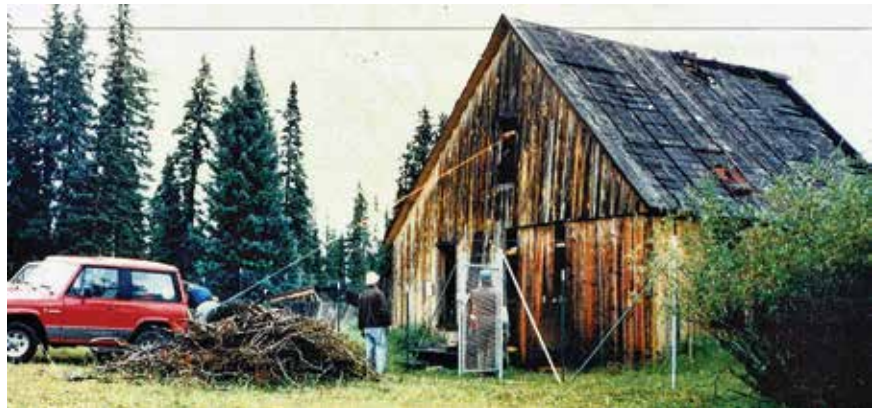
Photo by Tina Tebbens

*Car, plus chain, plus building? It would appear that the 1990 Friends crew is attempting to square up the sagging building so reinforcements can be placed. The building's color clearly shows the deterioration. You can see evidence of the covered-over garage door in the near corner of both of these photos.*

In 1990, Friends placed unspecified "new foundation material under the [sinking] southwest corner of the building," replaced second-floor joists and installed new roof rafters. The original rafters were spaced on four-foot centers; how the roof managed to support the typical Cumbres snow load is an engineering mystery, especially given the years that the building was unoccupied with an unheated interior allowing the accumulation of snow. The crew also replaced a "substantial amount" of the original roof decking with plywood and the trackside roof was covered with new "40-pound roof material." In a memo to C&TS Historian Spencer Wilson, Team Leader John Rupley proclaimed, "WOW! The makeshift garage door is gone..." from the southeast corner; the crew had framed a wall and window in its place and covered it with new board and batten siding. The *Dispatch* noted that stabilization continued by "installing two

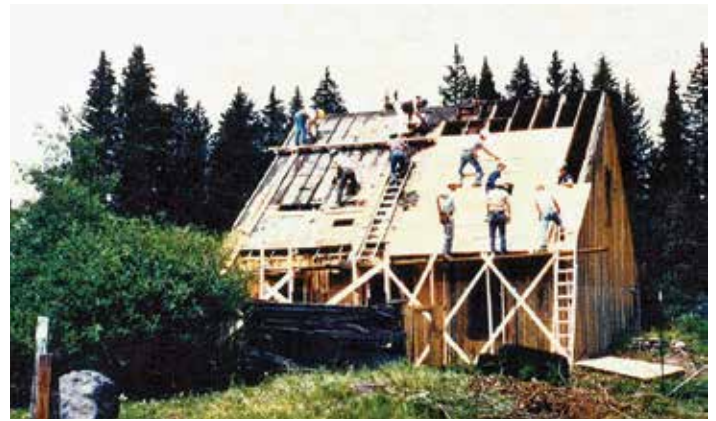
Initial roof repairs were begun in 1990 with at least ten Friends removing the old roofing material and replacing it with new sheathing.  
Photo by Tina Tebbens

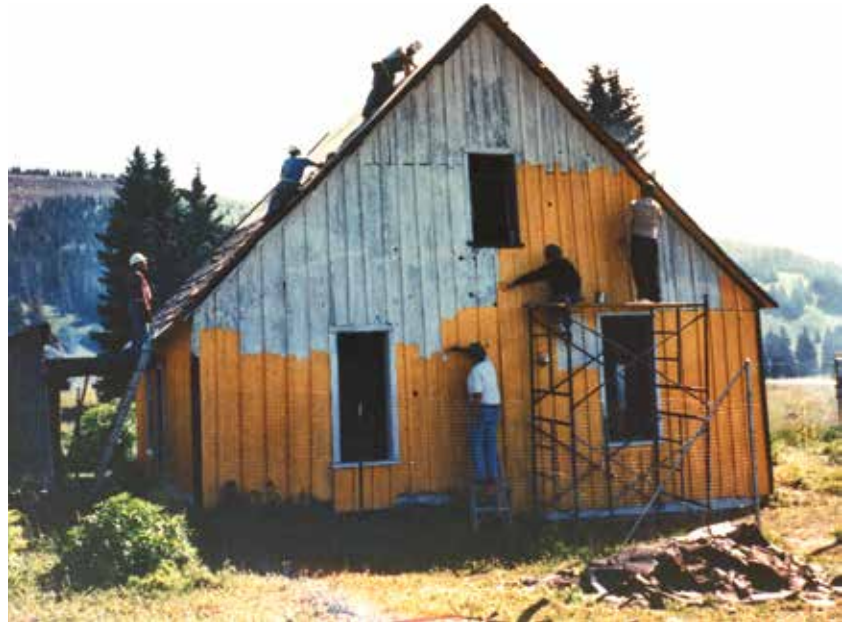
With work ongoing up on the roof, a Friends crew begins painting the Chama side of the structure.  
Photo by Tina Tebbens

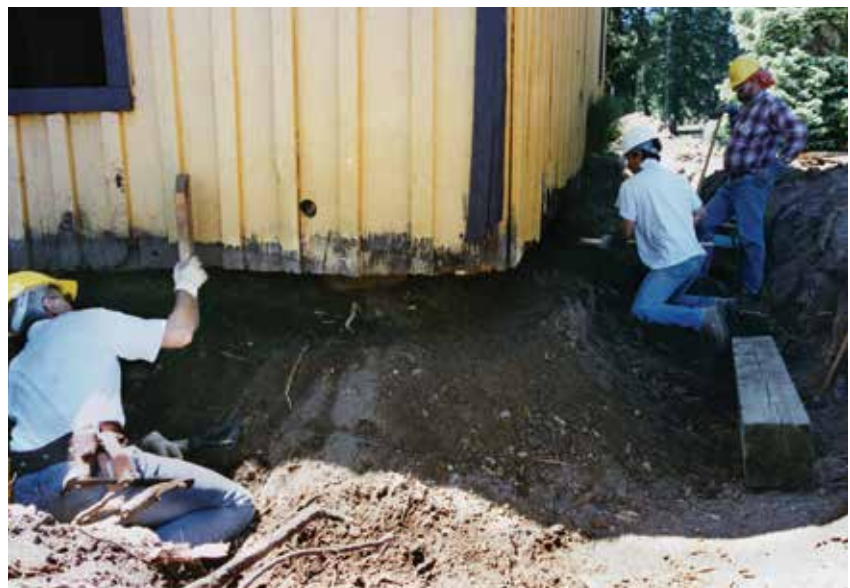
1995: Digging out the the original, rotten foundation and raising the structure to place a new, treated wood foundation and sill was arduous work.  
Photo by C. Edward Walton

The existing foundation, or what was left of it, was dug out by hand, section by section. After jacking up portions of the structure, a new bottom sill plate was placed around the entire building atop a 10 x 10-inch treated wood foundation. The upright 2 x 6 studs attached to the old timber sill were found to have serious decay at their base and each had to be “sistered,” that is, strengthened with new upright studs attaching the new sill to the original framing. With the help of a backhoe, a trench was dug, and plastic film and drainage pipes were laid around the new foundation and backfilled to protect the foundation from moisture, then graded for better drainage. The team added additional interior sheathing and roof cross ties to increase the building’s overall strength. For security, they added reinforced doors and shutters that could be closed and latched from the inside.

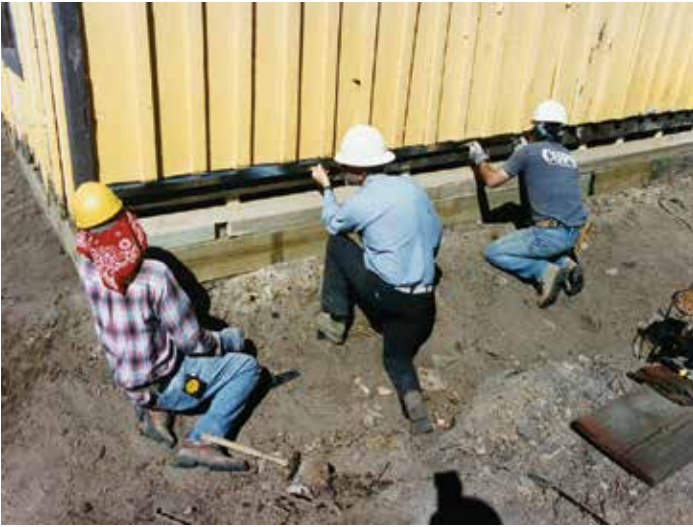
With the building raised slightly, a 10 x 10 treated wood foundation and sill plate was installed under the entire building.  
Photo by C. Edward Walton

Despite the new wood-sill foundation, it was determined that the building had settled nearly eight inches over the years, and the 1995 crew was not able to level it. The chimney had cracked and shifted, though it was unsure whether that was caused by jacking up the building or the overall settling of the entire structure. The top portion of the chimney was offset by a few inches though the crew thought it still seemed to be “securely positioned.” With much of the stabilization complete, the building was deemed to no longer be a threat of imminent collapse and the chain link fence that surrounded the structure was removed. By the

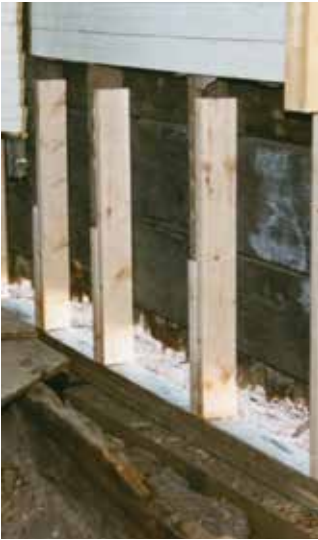
New sistered studs are attached to the new sill plate and original studs.  
Photo by C. Edward Walton

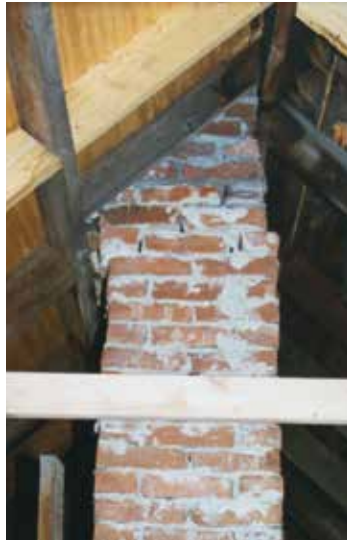
The Inspector's House chimney, 1995. Don't expect anything from Santa this year.  
Photo by C. Edward Walton

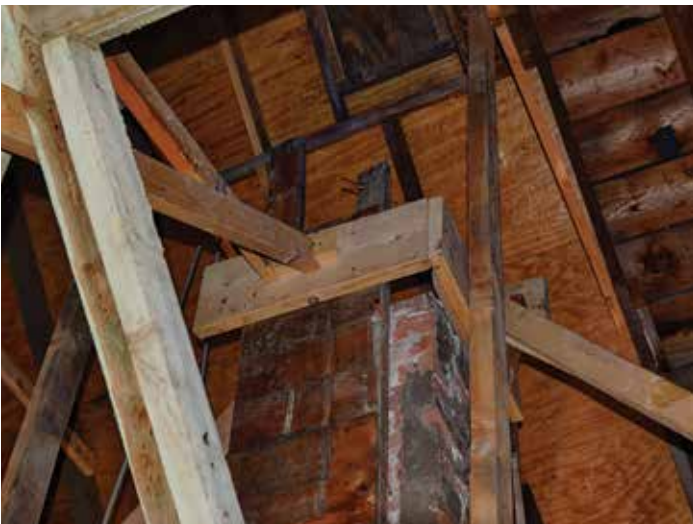
Some of the many attempts to shore up the roof rafters and rafter cross ties.  
Photo by Friends Chronicle Team

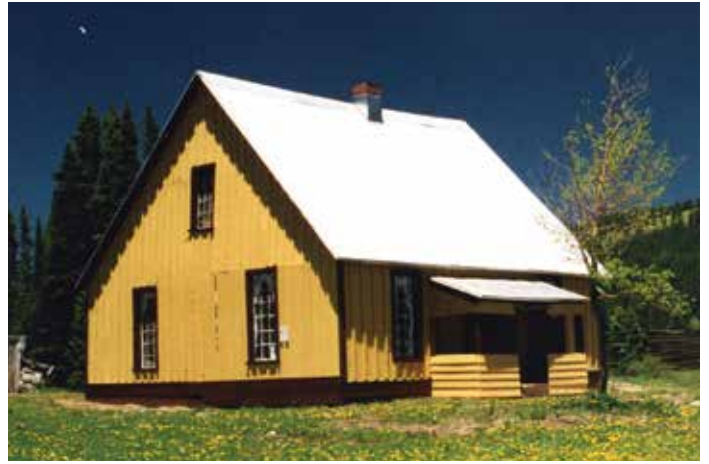
Not ready for occupancy, but by the end of the summer of 1995 the Car inspector's House was a much nicer looking piece of real estate and much more likely to remain standing.  
Photo by Glenn Hall

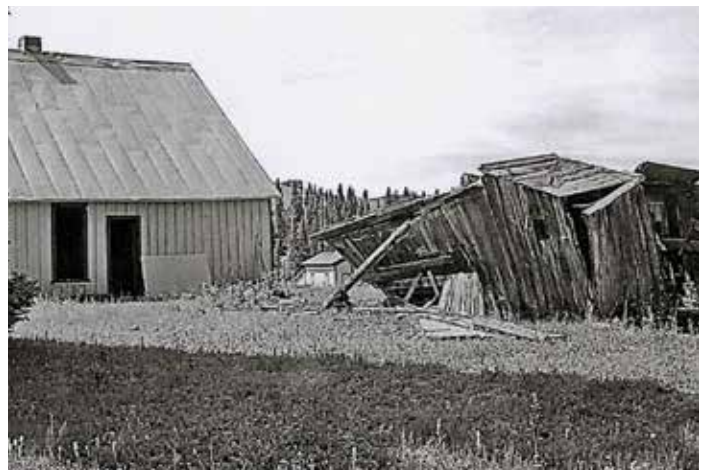
Behind the Inspector's House, the annex was basically a pile of rubble.  
Photo by Lynn Huber

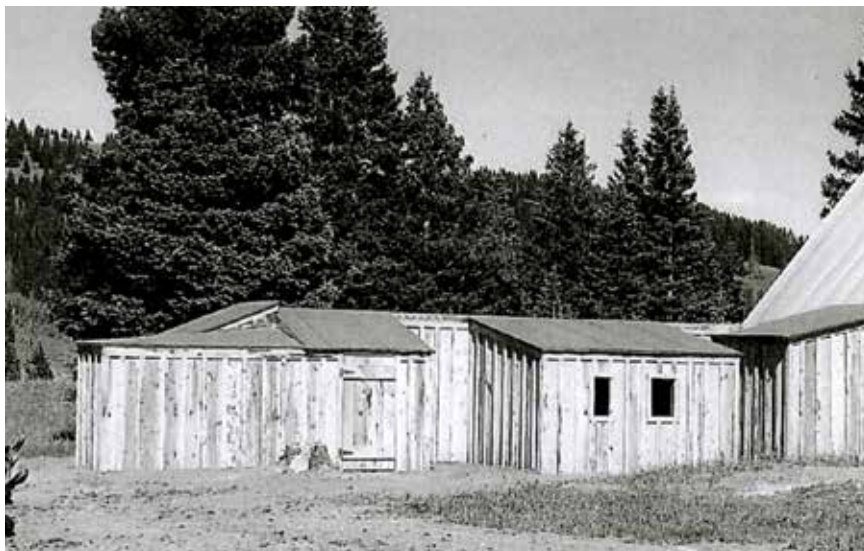
Image scanned from final 2011 Archaeology Report

After several delays, the reconstruction was completed in 2008.

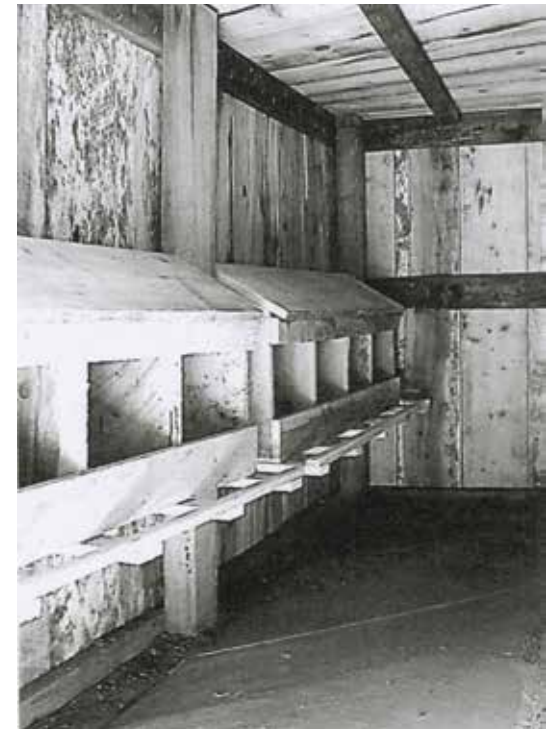
Volunteers created a period-accurate chicken roost inside the completed structure.

Heavy snowfall later that winter had caused some damage to the partially-completed structures but once repaired the following summer, board and batten siding was applied. For the animal pens, volunteers fabricated traditional chicken nesting boxes and roosts in the chicken coop and a feeding rack in the goat shed. The annex was completed during two sessions of 2008.

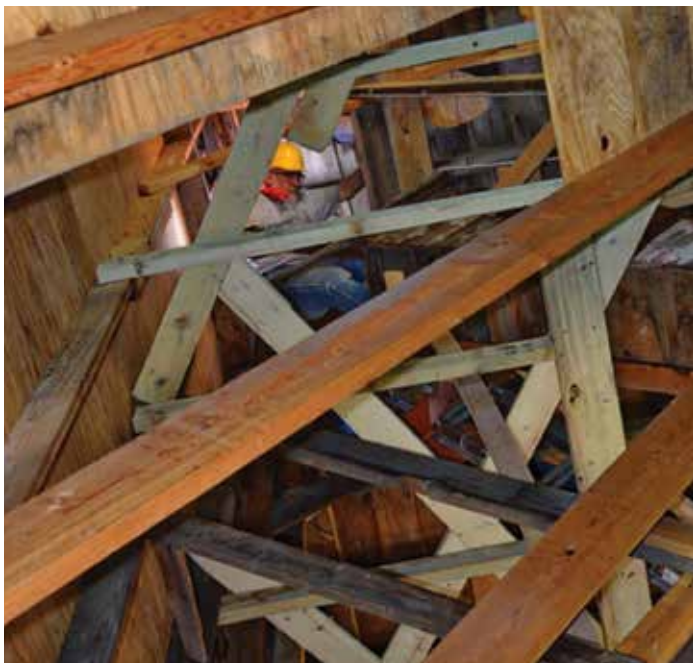
A 2008 structural inspection of the main house showed continued displacement of the Chama-side wall of the main building, the result of rotting framing and previous “railroad modifications” of the garage door. Additionally, bracing and plywood decking installed during previous stabilization activity prevented rafters to remain plumb in a safe manner.

Additional structural support was added in the attic in 2008 for long-term stability as no specific plans for the Inspector's House were on the table. Photo by Friends Chronicling Team

team had decided to install supplemental bracing supports in the attic area. Because no specific use for the building had been identified other than its historic significance, it was determined that repair of the building to make it structurally sound and restoration of the exterior to make it weather-tight was all that was necessary until future decisions could be made.
