## **Special Report, Part 2: Restoration of D&RG Pullman Tourist Sleeper 470, 2016–2021**

# RESTORATION: PART 2

## PULLMAN TOURIST SLEEPER 470

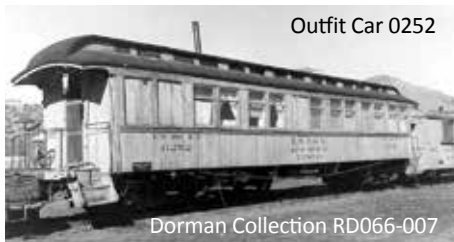
In December 1953, after sixty-four years of service, 0262 was retired to Alamosa. Many other ancient narrow gauge cars were simply burned with the remaining steel parts salvaged out of the ashes. Outfit Car 0252 was spared the funeral pyre but her steel parts were still stripped clean.

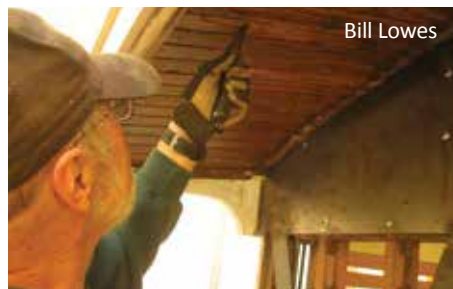
Most of the wooden "skin" was scrapped but the protected ceiling over the end platforms escaped the elements. Still, they needed scraping and eventual painting.

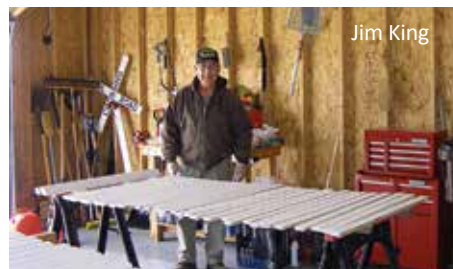
The rest of the car wasn't so lucky, so new tongue and groove siding was ordered. It was easier to add a primer coat to the T&G slats in Don Atkinson's garage than after installation.

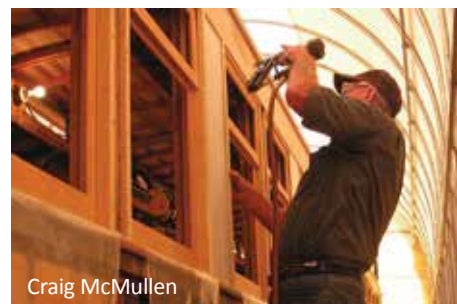
With the siding primed, installation of the tongue and groove could begin.

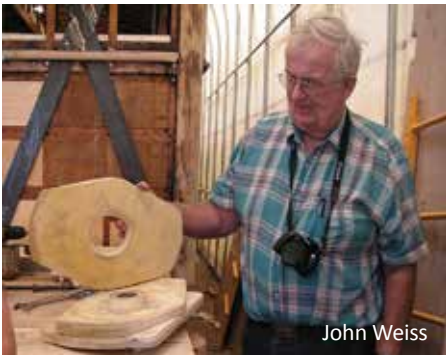
John Weiss, our master pattern maker, arrived with a wooden pattern of the pivot plates that would fit between the car and the trucks at the king pin. Checked for fit, it was perfect!

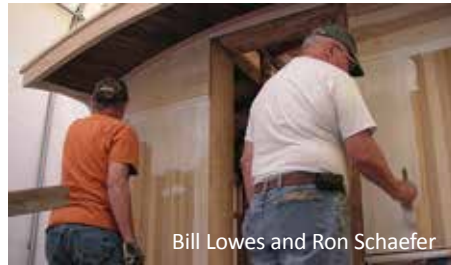
With the underside moisture barrier installed, the bottom was then sealed with cedar boards. The steel beams on the sills are not covered.

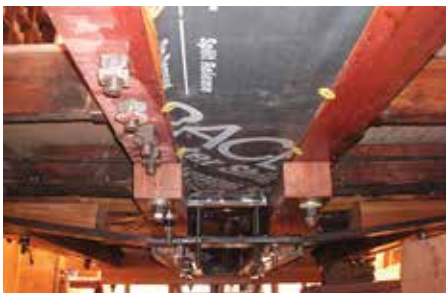
Placing the exterior T&G on the car ends was a challenge because of the steel X-bracing. Craig's solution was to pre-assemble the T&G together and then rout out the channel for the X-bracing.

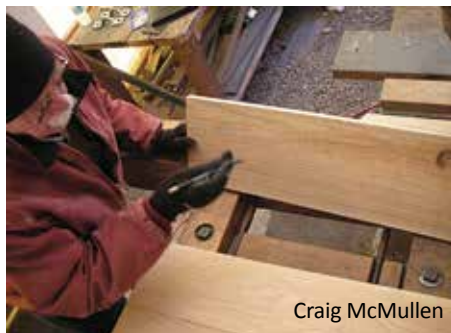
Craig began focusing on the finish work of the end platforms. This included the oak flooring for the platform itself and the steps. The flooring was drilled to accommodate the bolt heads in the framing.

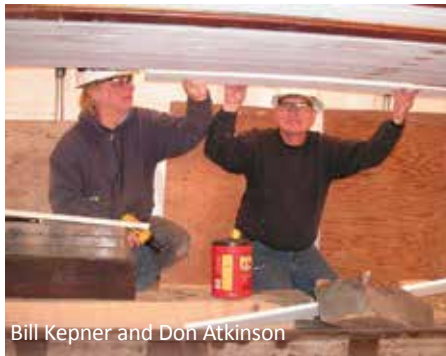
The underside sheathing, begun last year, was almost complete with the addition of the edge boards. They had to be cut to fit around the hardware protruding through the outer sill.

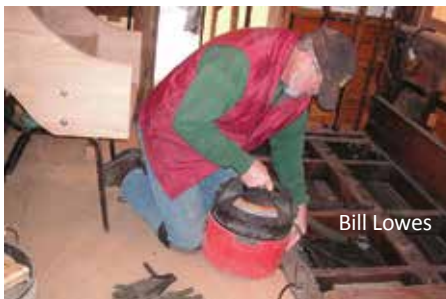
Before the interior floor could be installed, a lot of work needed to be done to clean up, insulate and seal the cavities between the sills and cross-members. First step: vacuum out the dirt and sawdust.

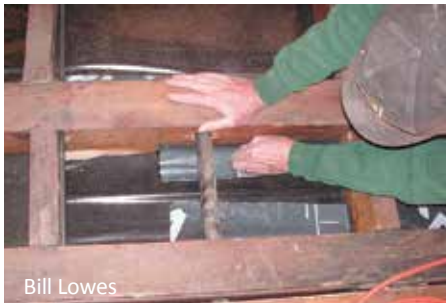
The space was then lined with adhesive plastic sheeting.

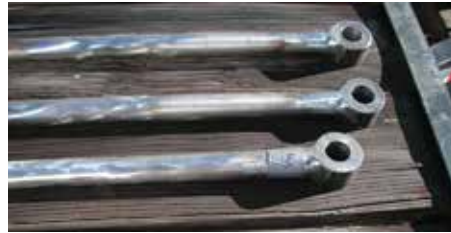
It was time for the final installation of the under-the-car longitudinal truss rods. The pin and screw ends on each rod had already been crafted by Russ Hanscom.

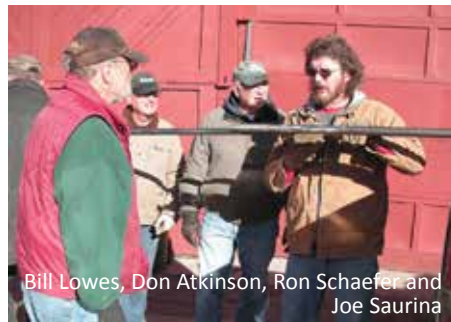
Joe Saurina cut them to length, welded the ends in place and threaded the other end of each rod to accept the adjusting turnbuckle.

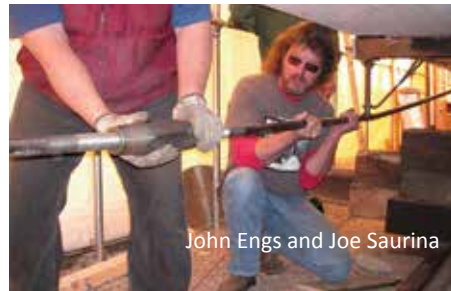
After bending the rods to fit, they were installed under the car with the massive turnbuckle tightening them to the proper tension.

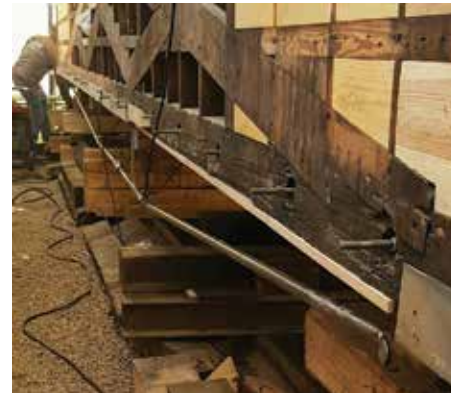
Here's one of the truss rods fully in place under the car.

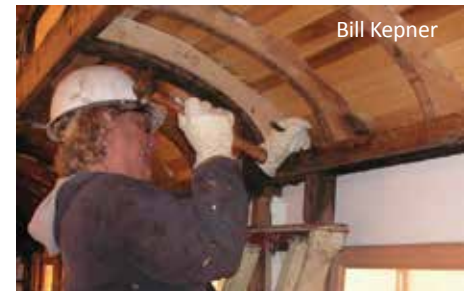
The final tightening of the high-tensile bolts (to 200 psi) holds the steel angle compressed down on the length of the car.

Bill Kepner also nicked so the bolts would never come loose in both the floor and the carline roof.

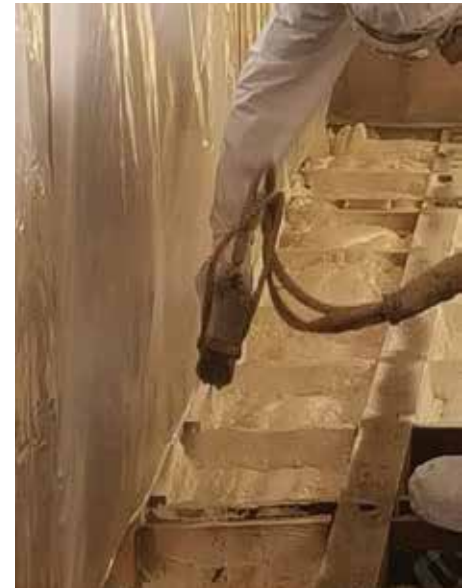
With that, the car was ready for a professional insulation crew who sprayed in foam in the sub-floor and roof clerestory cavities.

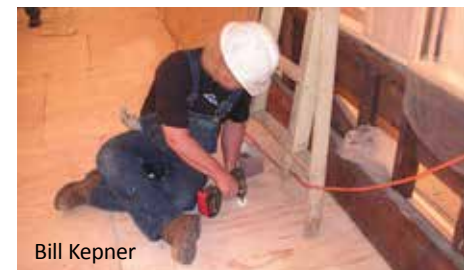
With the insulation complete, the sub-floor could be installed.

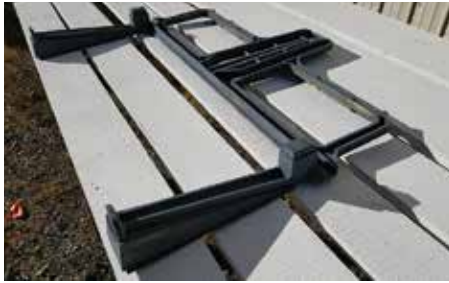
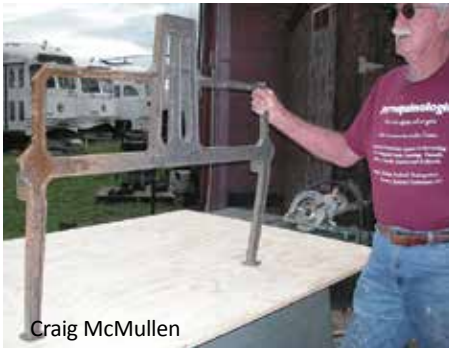
John Weiss created wooden patterns for the seat-bed platform frames. These would be professionally cast and delivered to the Colorado Springs site.

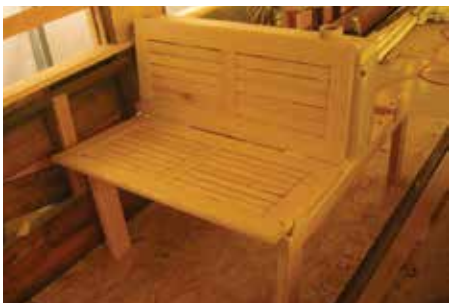
Each set of two seats is made up of a pair of cast side frames. Chair frames at either end of the car are half-sized with a single set of seats. Each chair folds down to create both seat and back sides. Tourists were traveling "economy class" so the original chairs had no cushions or other padding.

Back at Craig McMullen's shop, Craig began assembling a prototype chair based on the few existing drawings and photos, including the half-size seat.

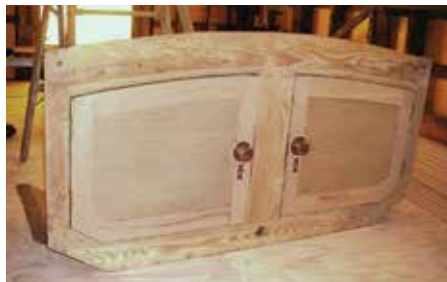
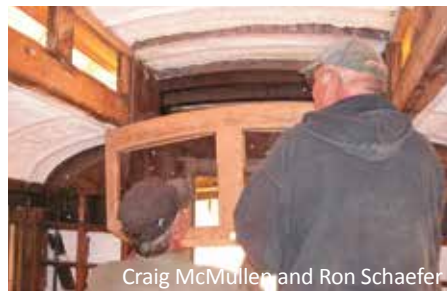
However, before installation of the interior T&G ceiling could be completed, the two end cabinets needed to be reinstalled. Early on in the project, Craig built replacement cabinet doors.

The original frames were refinished and reused and the cabinets re-hung. With the cabinets in place, work could finish installing the T&G ceiling

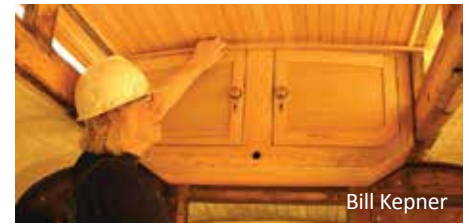
The end of 2017 saw work continuing on the finish carpentry, both inside and outside of the car. Trim around the end cabinets was installed.

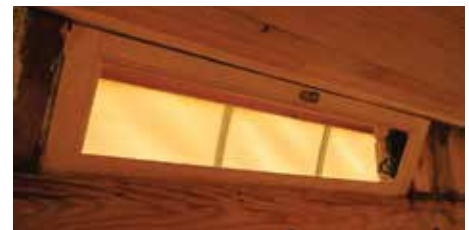
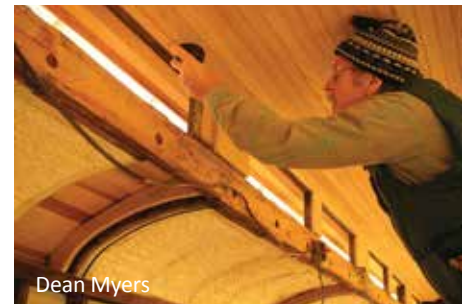
Clerestory window trim was put into place, along with trim boards below the windows

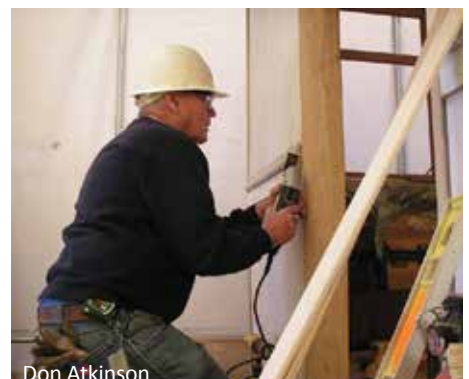
The crew also began installing the exterior trim as well.

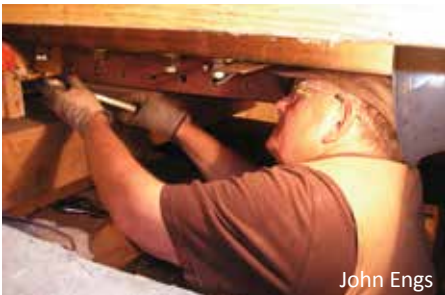
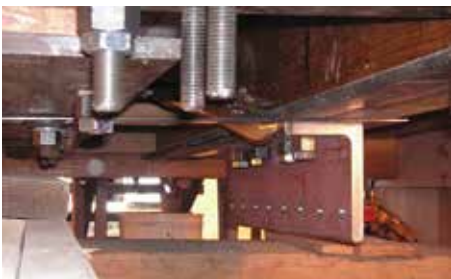
This involved removing the nuts on the long bolts going through the inner sills.

The brackets were previously marked and drilled and were now being bolted in place.

The brackets would support the coupler mechanism to be installed later.

The “underground crew” continued work on installing the support angle brackets for the coupler pockets. The coupler pockets have a shock-absorbing mechanism to lessen the impact on both the car and the passengers

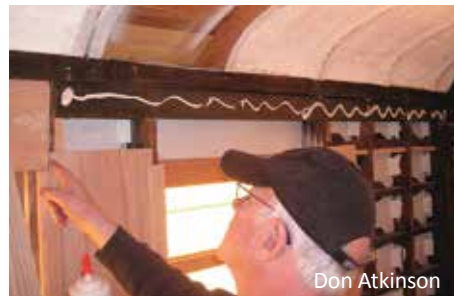
In some parts of the car there was no wooden frame for nailing. This was because the steel “cage” that formed the structural frame of the Car and in those places, the trim had to be glued in place.

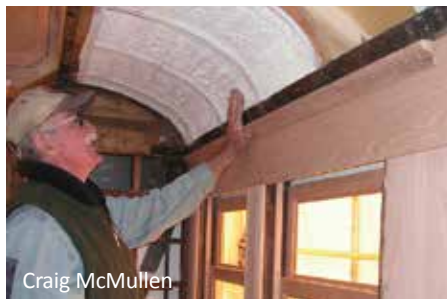
Elsewhere, Craig installed crown molding over the windows.

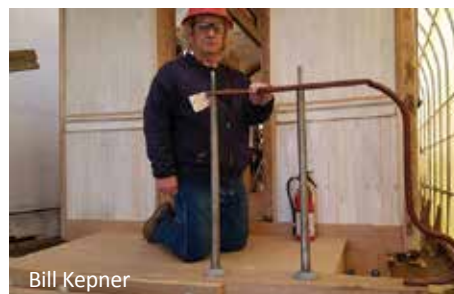
Outside the Car, work was progressing as well. Joe Saurina created handrails for platforms and steps.

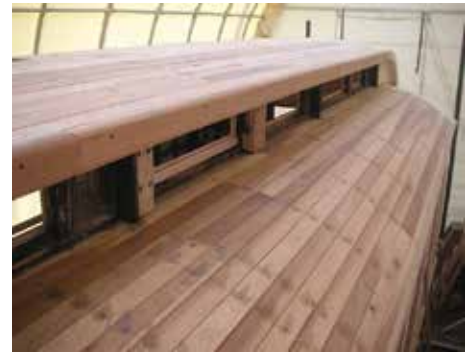
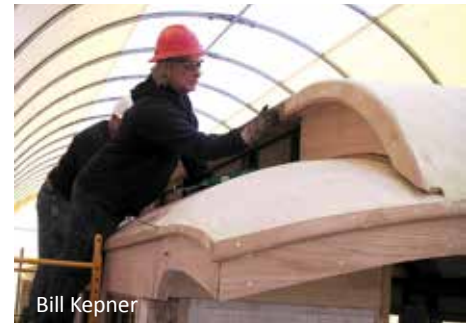
Up on the roof, the final sanding began in preparation for the copper roofing material.

Prior to that, all the nail holes had to be caulked and smoothed in preparation for installation of a leak-barrier membrane.

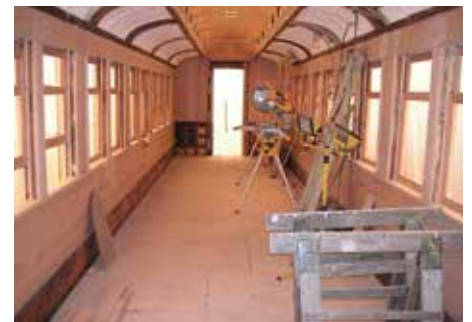
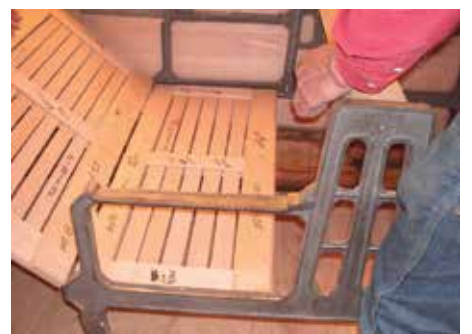
By mid-April the walls were nearly completed and the cast seat frames had been delivered, so the crew started assembling the seats.

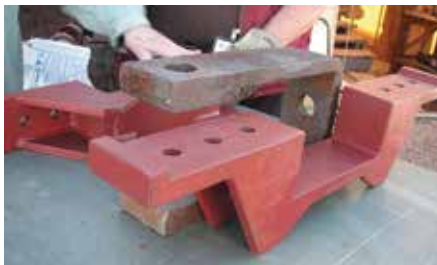
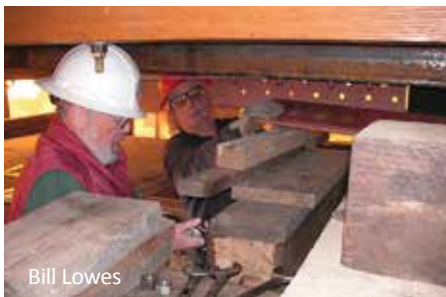
...and manufactured by Joe Saurina.

Work continued on fitting the steel brackets to the steel on the inner sills of the car to support the coupler mechanism. The space was tight, but better than without a pit. Hard hats were highly advised.

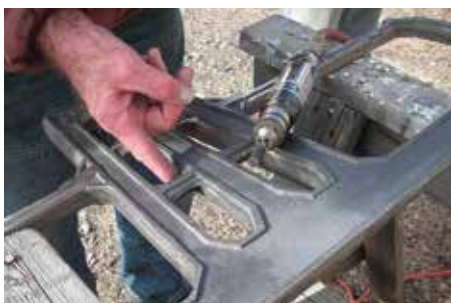
As seat assembly began it was discovered that the cast iron frames had a lot of "slag" that needed to be ground off, a slow process with all the edges and corners.

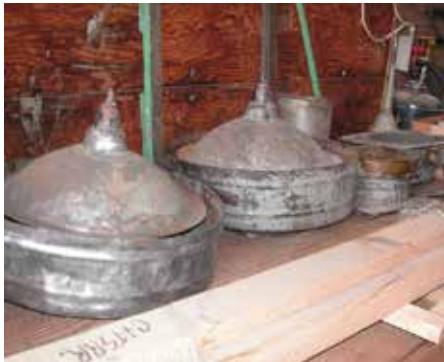
Many of the roof vents are located above the men's and women's "saloon" facilities.

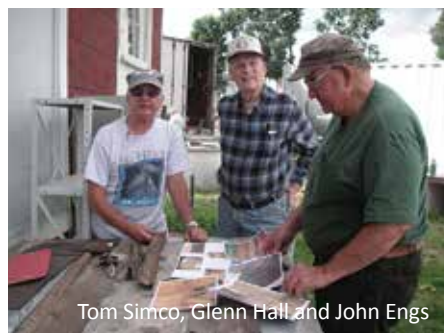
Tom Simco is the Friends' resident metal bender so he, Glenn Hall and John Engs planned the copper flashing that would fit with the clerestory

windows, based on the original flashing taken off the car before restoration. The new flashing, along with a new copper roof, would be installed the next year.

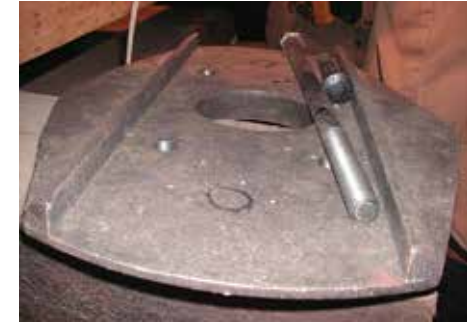
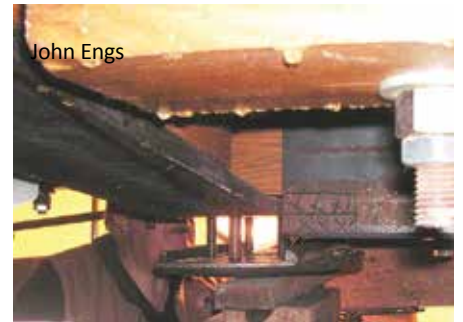
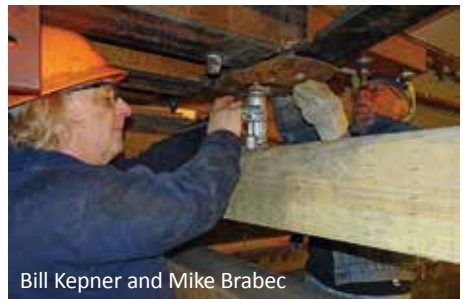
A major, and fairly difficult, project in 2018 was the installation of the pivot plates between each truck and the bolsters under the car body.

The pattern for these plates had been made by John Weiss back in 2017. The plates were cast and were ready for installation.

The plates (or bowls) needed some drilling and fitting and it was a tight space under the car to work.

But with the plates in place, most of the under-car work was done. The Car would be shipped to Antonito for final installation of the trucks.

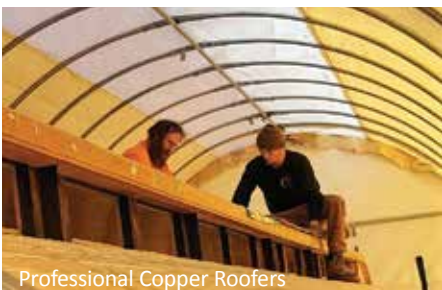
Professional roofers were hired to install the lead-dipped copper roofing over the car and clerestory.

The roof joints were folded, pounded closed and soldered.

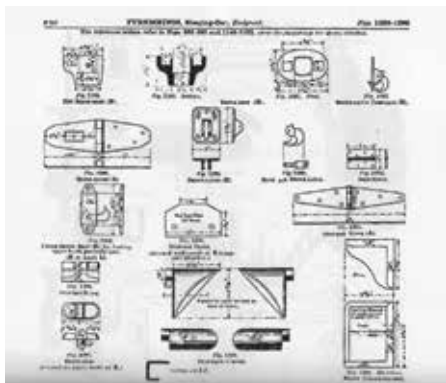
A page from the 1888 Car Builder’s Dictionary.

None of the brass parts have been available since the Car was built and there is very little information on what processes were used to make the parts. For reference Ron consulted the 1888 *Car Builder’s Dictionary* which provided both diagrams and measurements.

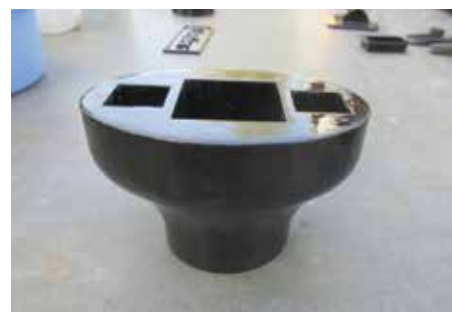
The largest of the 3D patterns was the berth stop, the piece that supports the upper berth when lowered for sleeping. Printing the 3D master took almost eight hours.

The finished berth stop pattern.

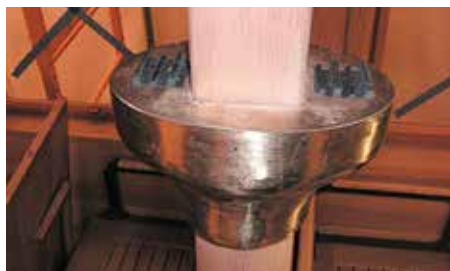
*One of the finished berth stop blocks in place in Car 470.*

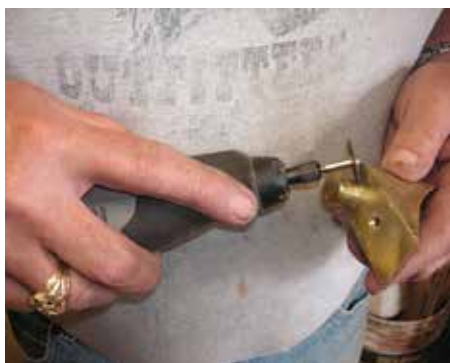
These were cleaned, shaped and polished using grinding belts with various grits to give them their final brilliant brass finish. Says Ron,

“When I received the rough castings, the real work started. I spent many hours cleaning and polishing all the rough castings in my shop.”

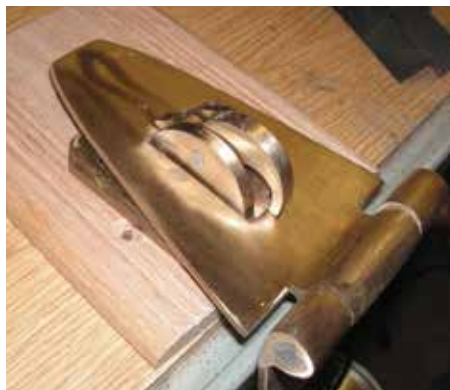
Some of the more intricate parts required casting several different pieces for final assembly. Each upper berth, for example, included a movable latch to keep the berth raised during the

*The combined multi-piece latch and hinged clasp keeps stowage of the upper berth securely in place.*

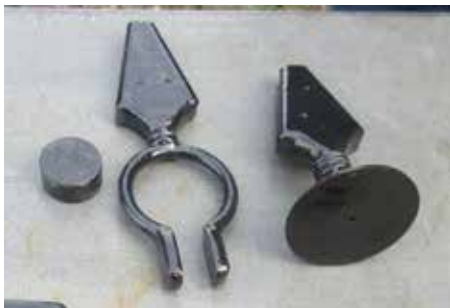
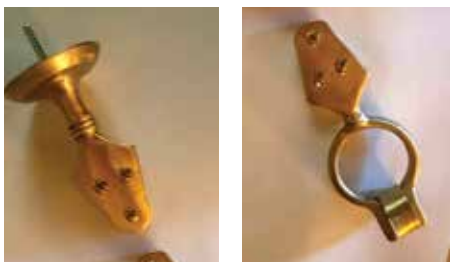
There were also many small castings such as the two ends of a leather hanger that supported an emergency cord that ran the length of the car.

*Patterns and finished hardware for the emergency cord supports.*

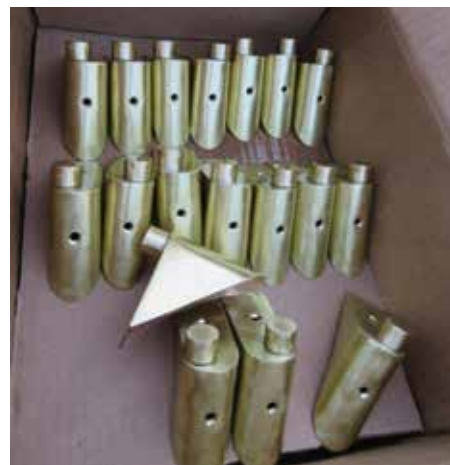
Small pieces such as the seat corner guides were too thin and delicate to be cast so Ron built them by hand.

Each piece was identical with a bracket that fit over the seat corner, with a round bar that guided the seat as it traveled through the metal frame. There were two on each seat frame so Ron created 48 of this particular piece, each crafted individually.

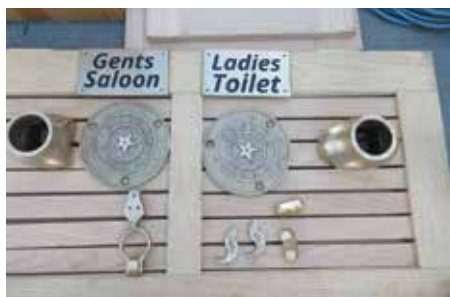
*Signage, builder's plates and many tiny pieces were cast as well.*

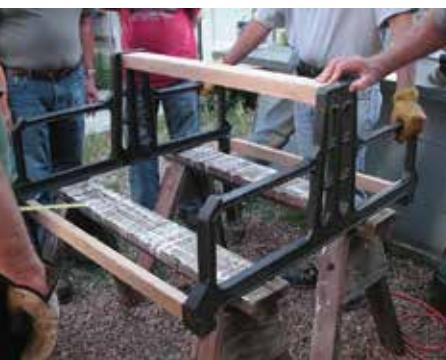
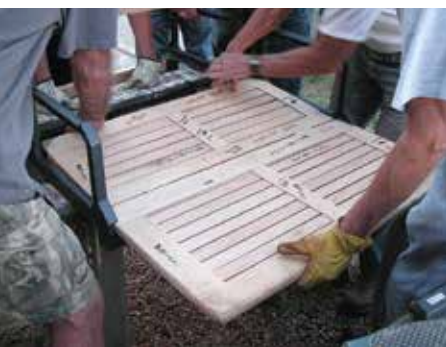
It was found that the seats tended to bind up in the frame when being lowered into the bed position. The

problem lay in the corner peg negotiating the track in the frame.

This meant each seat frame needed some additional grinding to modify the tracks for smooth operation.

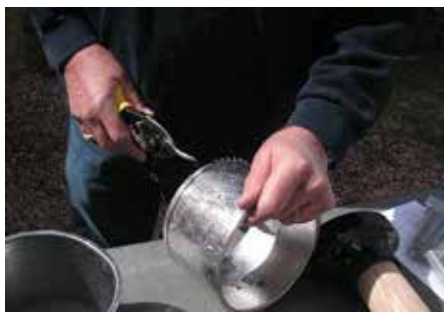
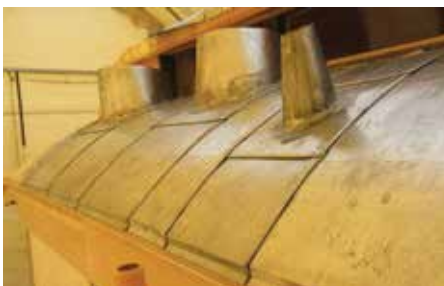
All exterior vents were salvaged but all transition pipes were replaced. A new air funnel was designed and manufactured.

The roof vent sleeves were soldered in place on the copper roof.

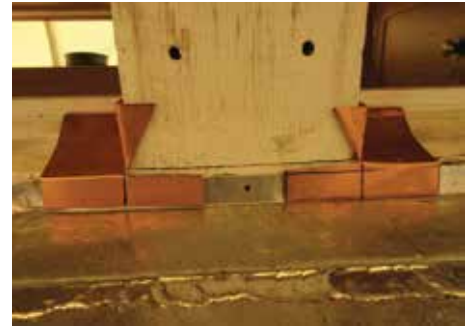
Ron Schaefer created replica copper flashing to fit around each of the clerestory window pillars. He began by cutting copper

squares and then bent each one into a origami-like shape that wraps around the pillar.

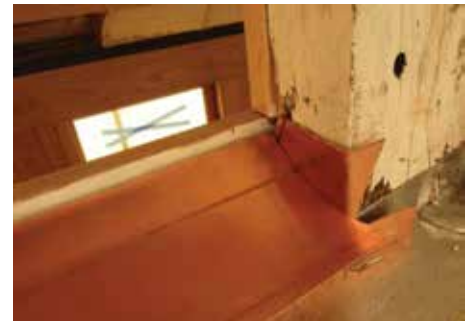
Meanwhile, Tom Simco folded larger pieces to form the bottom of the clerestory window. The parts were soldered together and then soldered to the copper roof.

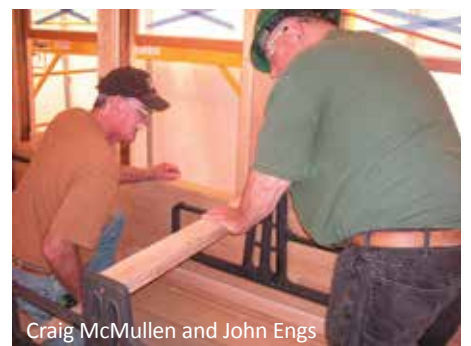
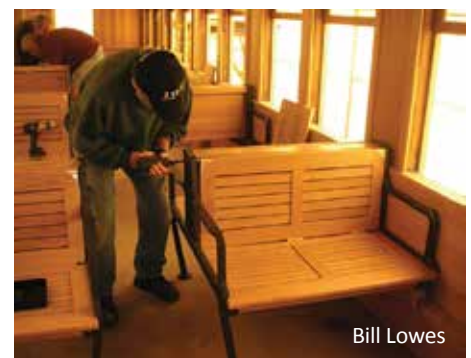
With the hanging corner peg problem solved, assembly of the seat and bed platforms began and soon became an assembly and installation line.

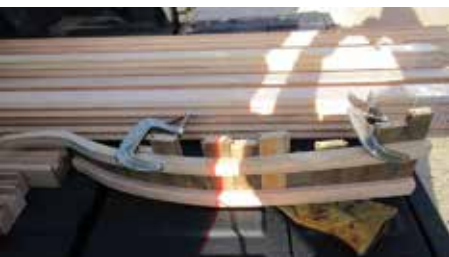
While most of the rest of the Car’s carpentry was fairly angular, the curved wall was an interesting challenge.

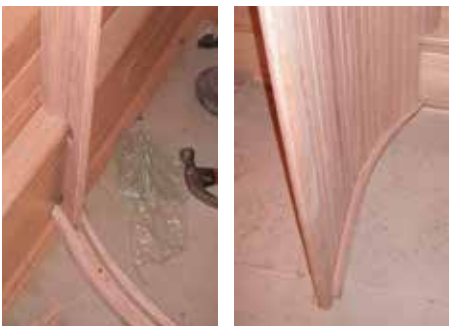
Craig milled oak boards to create tracks that would accept the T&G wall materials. These were bent to the radius of the curved wall.

From there the T&G was set into place and secured.

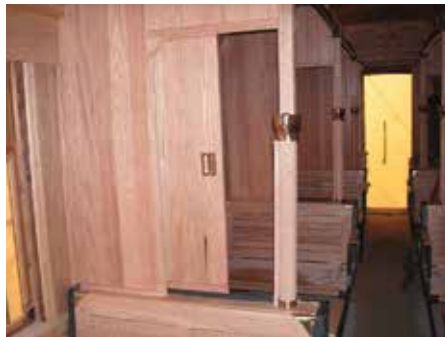
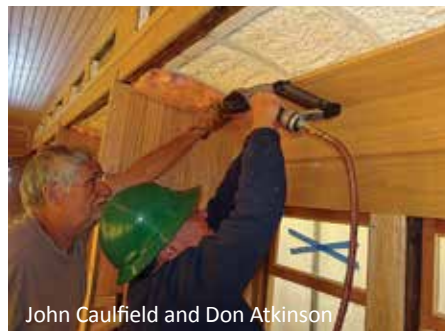
Between each of the sets of seats there was a “privacy wall” that could be closed off with sliding doors and a curtain rod.

Once the walls were in place, work could begin closing up the ceiling with more T&G red oak.

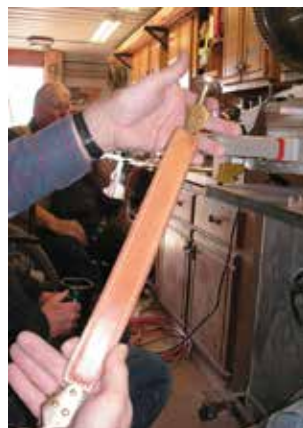
On the aisle side, each seat has a post that includes three parts: a brass cup where it meets the seat, a brass casting that supports the upper berth when it is lowered, and a cast iron arm that attaches the post to the ceiling of the car.

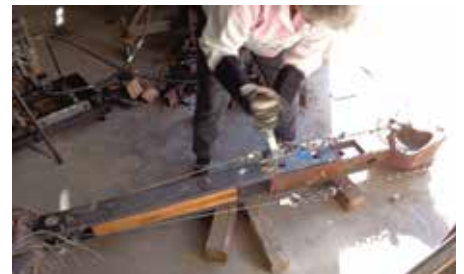
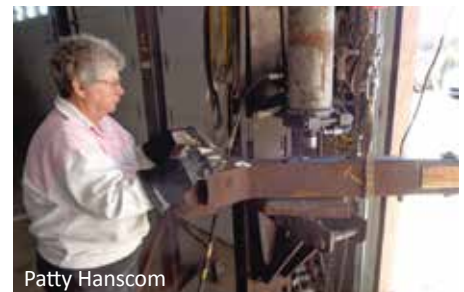
In Farmington, New Mexico, Russ and Patty Hanscom assembled the couplers that would be installed on 470 in Antonito. Steel pieces with wood spacers were attached to the coupler with rivets. The rivets were seated with a hydraulic press.

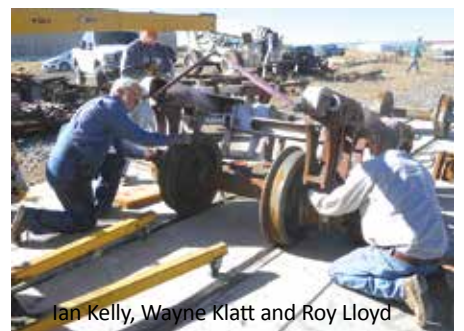
In Antonito, Ian Kelly and others spent several years assembling trucks, not only for 470 but for several other historic passenger cars as well. (See the *C&TS Dispatch*, Winter 2020.)

The frames were built from the ground up and existing narrow gauge wheels were added to the trucks. Now all they needed is Car 470.

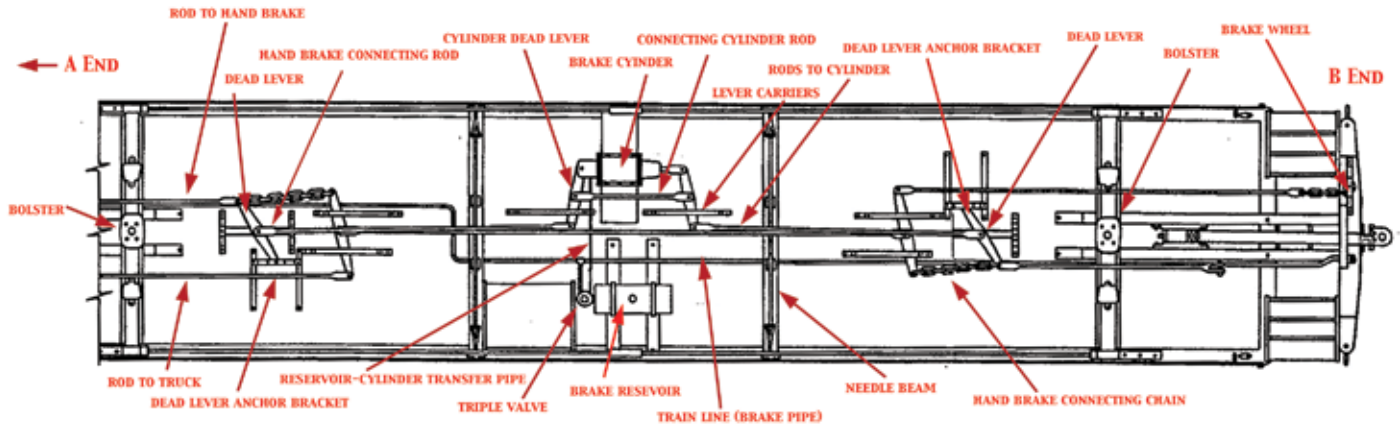
**AIR BRAKE COMPONENTS, PULLMAN TOURIST SLEEPER 470**  
AS SEEN FROM UNDER THE CAR, LOOKING UP

When our restoration project started, the C&TS shops recommended the Car be rebuilt using a newer "K-Type" system to be compatible with everything else that was operated on the C&TS. Those components were acquired from other retired rolling stock and stored for later use.

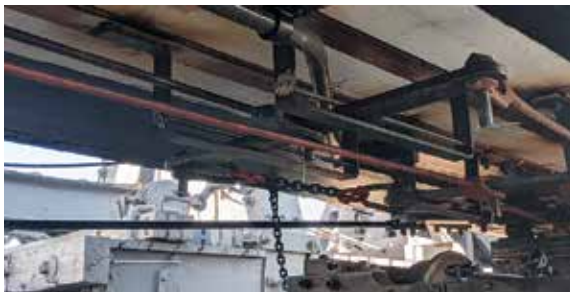
More than air: air brakes include a series of levers, reservoirs, chains and connecting rods on every car.

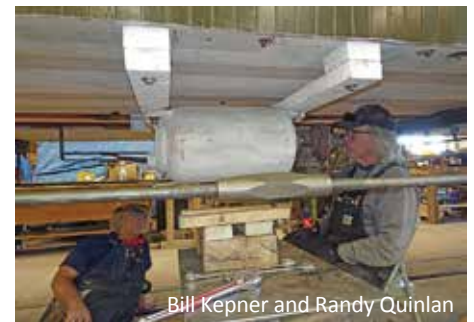
Bill Kepner and Randy Quinlan inspect the air reservoir near the center of the Car.

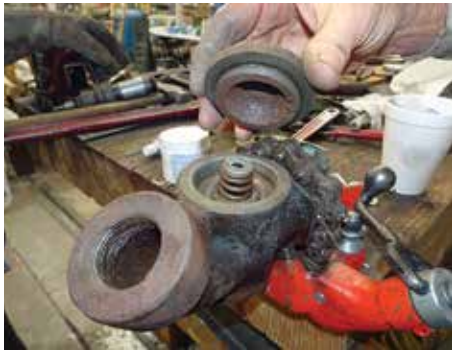
The angle cock, the air valve at the end of the car, came from a scrapped car. It needed some cleaning before installation.

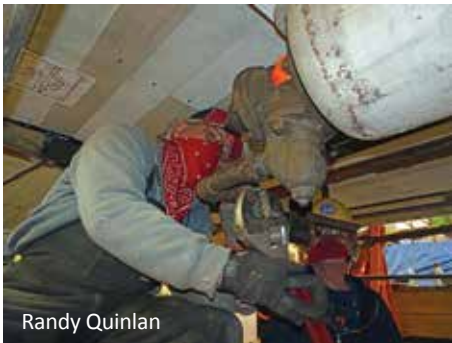
The triple valve was cleaned, inspected and mounted to the air reservoir.

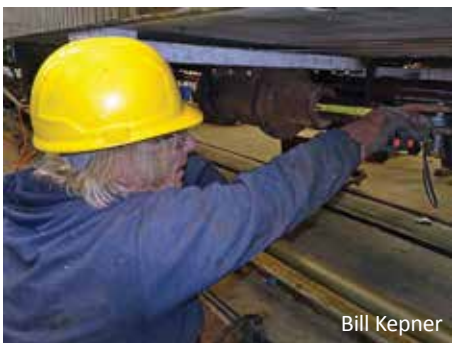
Bill checks the length of travel on the piston of the brake cylinder.

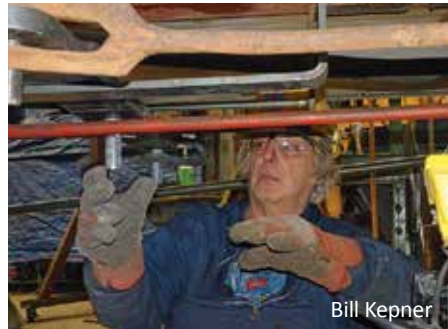
There are a lot of components that make up the brake linkage under the car that must work together.

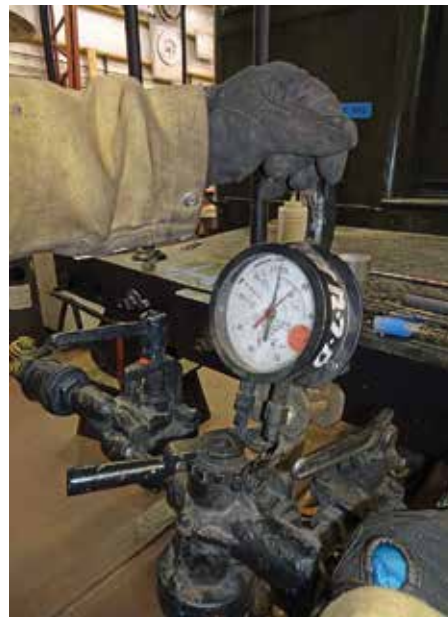
Charging the air lines and checking for correct pressure and leaks.

After final inspection of all the brake components, the brake lines were charged and tested. With everything working as it should, the Car was ready to be sent out on the line for further inspection. There was still a lot to do to finish the interior and the exterior of Car 470, but the Car was ready to roll and the brakes were ready to stop it.

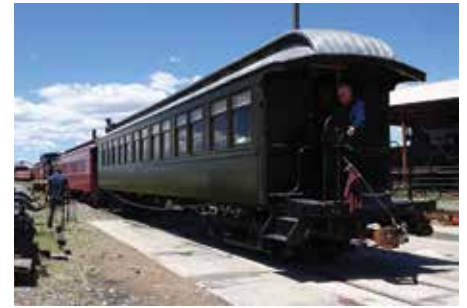
Ready for her first trip over the line!

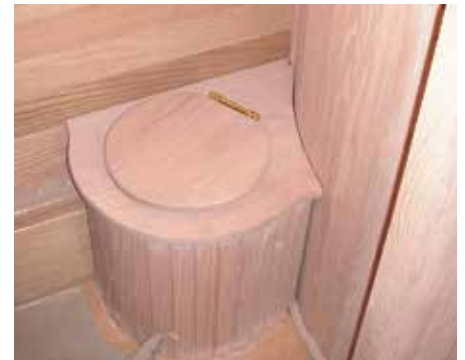
Some fine detail work was done on the men's and women's "saloons."

And no, they are *not* functional.

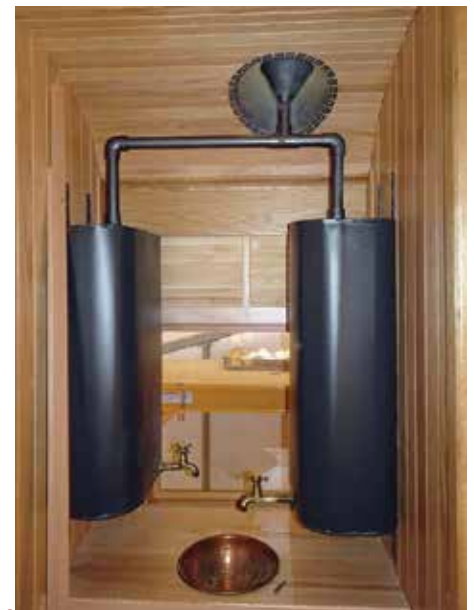
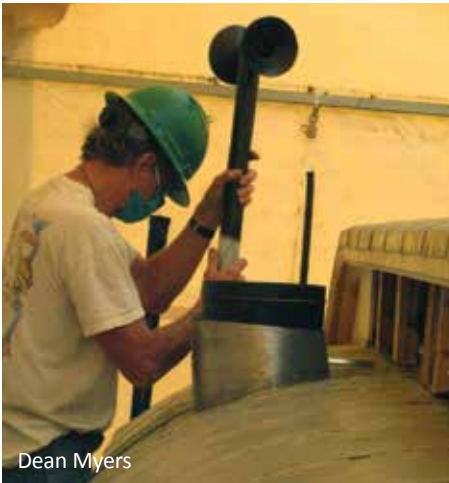
The Ladies Saloon received a water tank and sink. The gent's saloon used the sink at the water station. They are

filled from above through the vent in the ceiling.

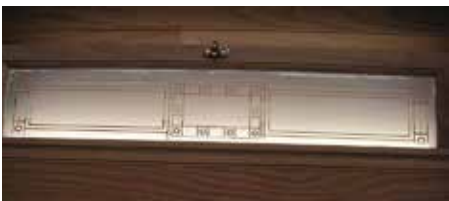
These vents draw air out of the lavatory areas using Bernoulli's principle (remember high school physics?) The trumpet collects air forcing it into the saloons allowing the existing air vented to the outside through the original vents.

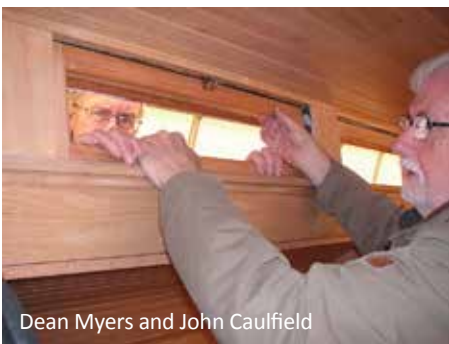
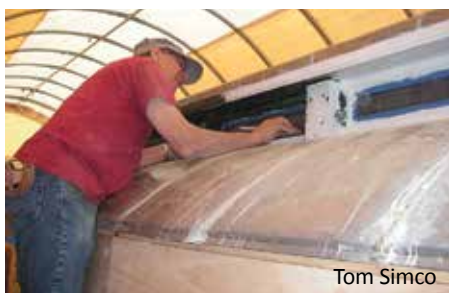
The 28 clerestory windows were ready to install. A surviving piece of etched glass from the original car was

used to create glass for each of the clerestory windows.

The windows were put in place and, because of the small and complex nature, had to be primed by hand.

Originally the window could be tilted open toward the inside of the car and notches would hold it open to various degrees. It was decided that these windows will not be operable but will retain the original look.

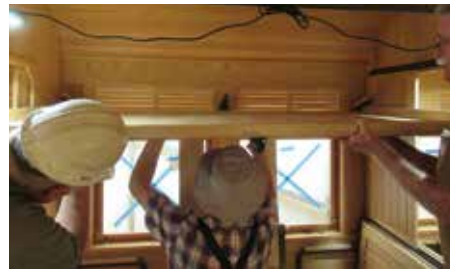
The twelve upper berth platforms were installed and leveled. Each berth was heavy and it was a monumental, three-person task.

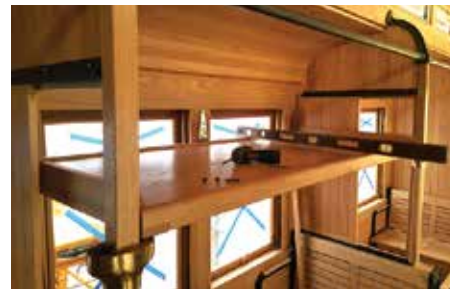
Portions of the car were masked and protected and a coat of glossy finish was applied.

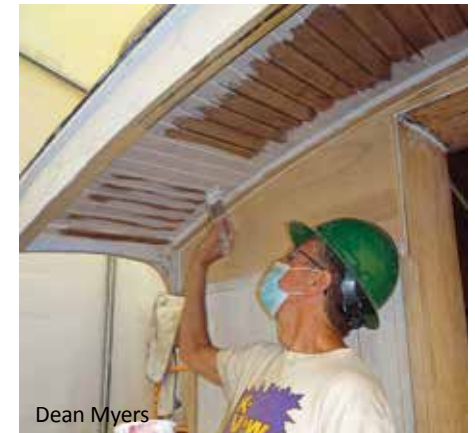
The ends over the platforms, however, still needed priming before painting could begin.

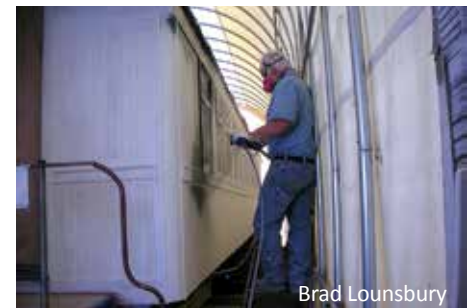
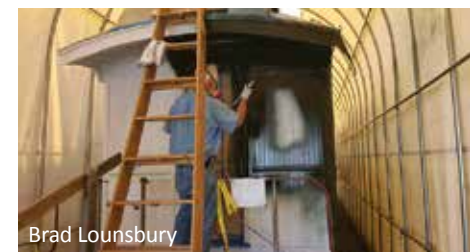
With the priming complete, Brad Lounsbury arrived to apply the top coat of Pullman Green.

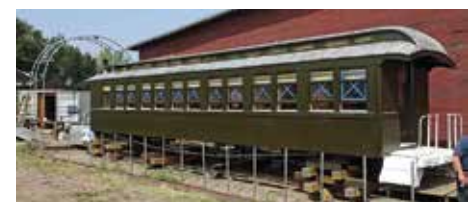
The painting is done! Now Car 470 can be exposed to the elements and admired in its entirety!

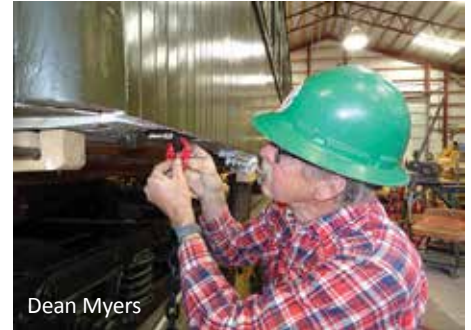
Highlighting the Pullman Company on the site-built trucks, the text on the letterboard, and her number would make George Pullman proud.

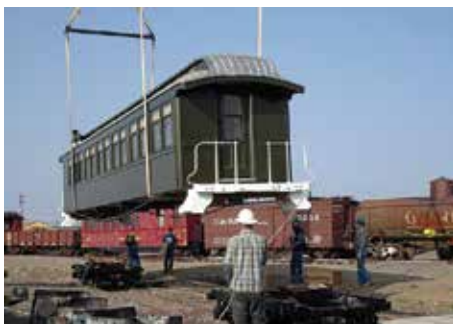
Rolled into the Ed Lowrance Car Repair Facility (CRF) on the site-built trucks (see page 17 and *C&TS Dispatch*, Spring 2021), Car 470 was ready for assembly and installation of the air brake and coupler mechanisms (see pages 18-19). From there the couplers could now be installed.

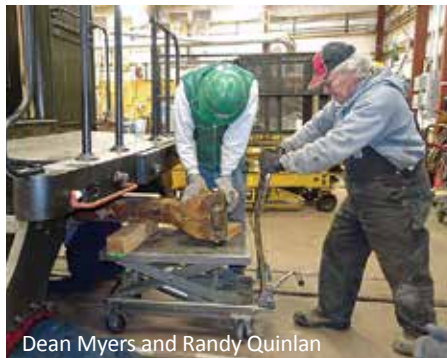
There was still some detail work to be done such as painting and trimming out the railings and grab bars.

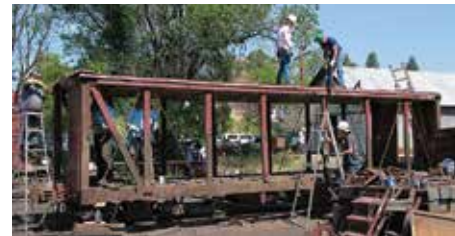
Converting P-Box 207 to a Rider Box Car.

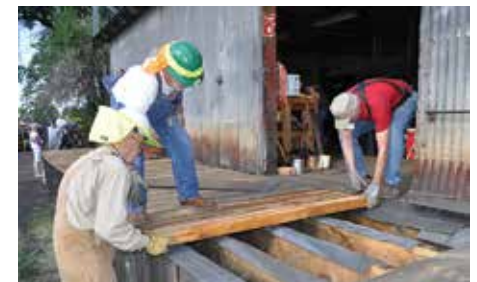
Repairing the deck at the Carpentry Shop.

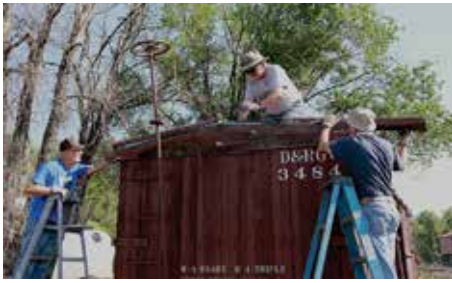
Roof repairs on Box Car 3484.

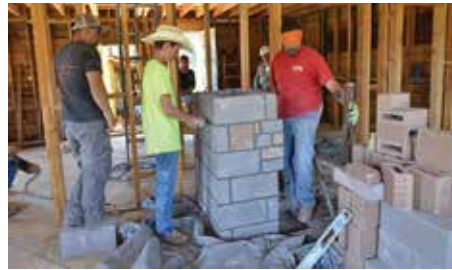
A new chimney in the Car Inspector's House, both inside...

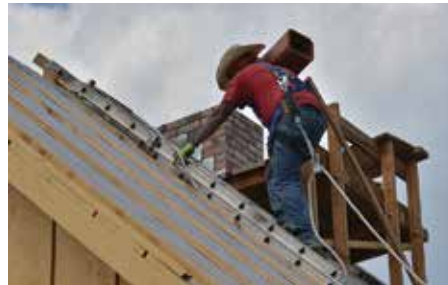
...and outside.

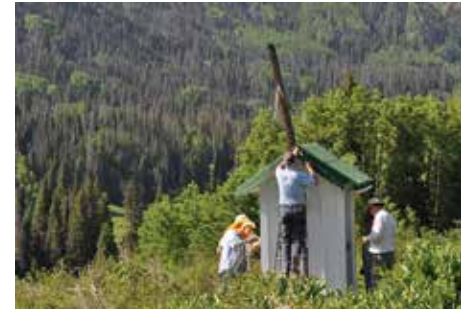
Telegraph booths got some needed repairs.

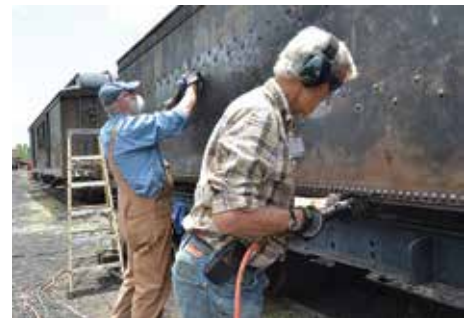
Locomotive 483 now has a tender!

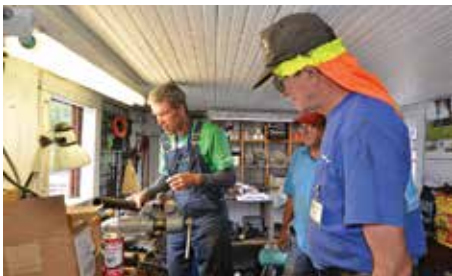
Mechanical maintenance of brake parts.
